Maserati Rinato

1960 Maserati 3500 Vignale Spyder (vin #101-923) (Number 2/243 production)

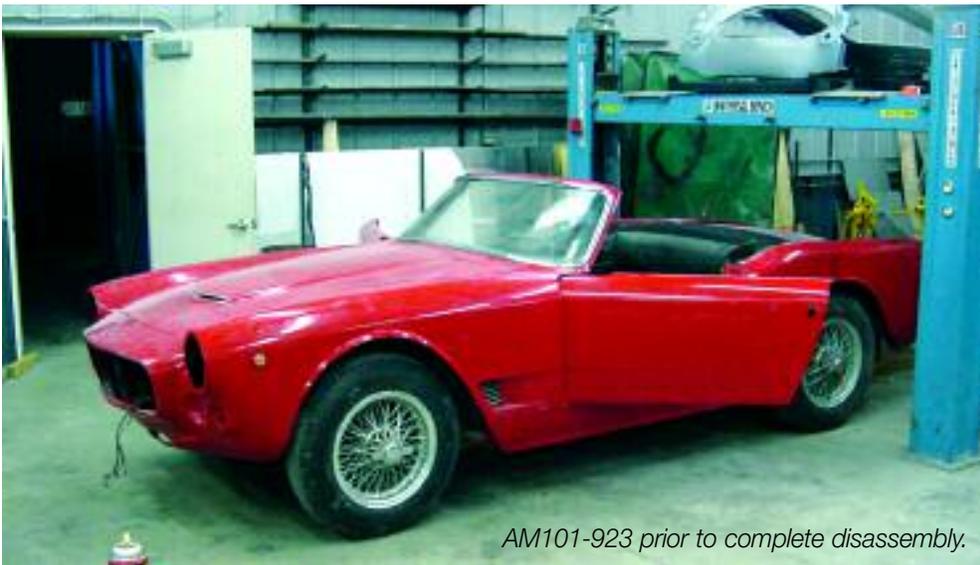
AM101-923 prior to complete disassembly.

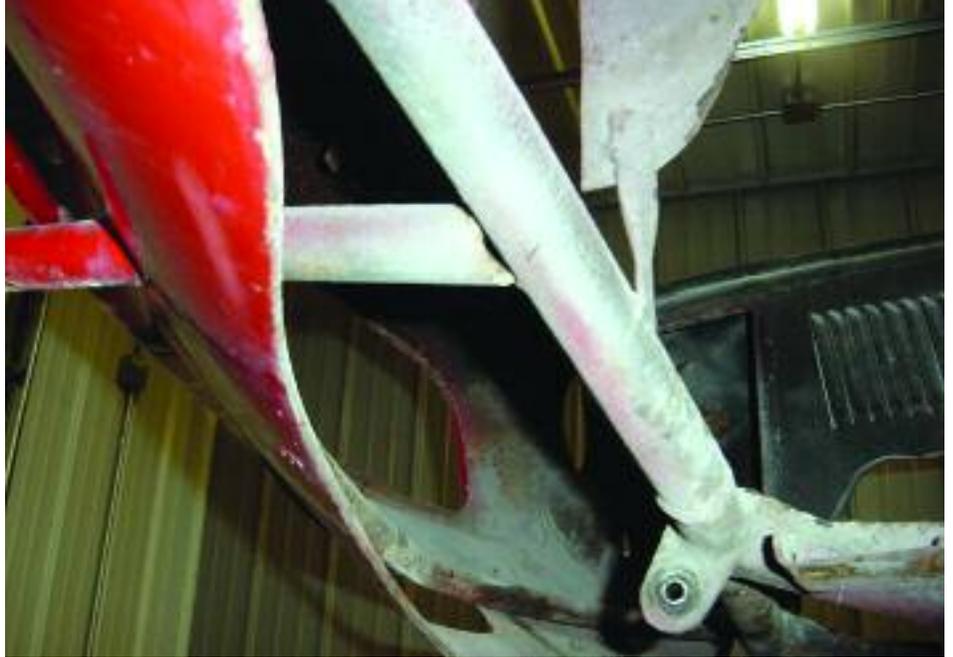
During the disassembly process we discovered a number of areas with incomplete welds and jiggling. This is common in low production hand-built cars; our approach is to enhance the structural integrity of the automobile where necessary, while retaining its originality and authenticity.

Front bumper frame extension only partially welded from the factory.

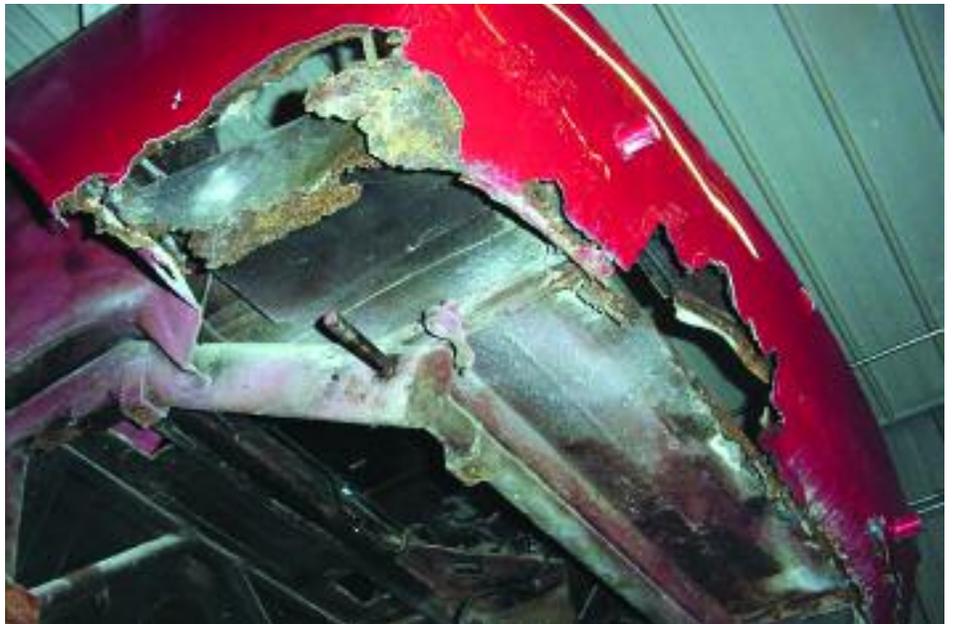
Some of our initial discoveries were the severe rot and corrosion on the entire rear lower body and outer structure. Once the body skin has been removed from the tubular chassis, the body skin will be chemically dipped and the tubular structure will be sand blasted. This process will allow our fabrication team to completely inspect, jig, and repair/replace all area affected by rust and corrosion.

Evidence of serious rot and corrosion damage in rear structure/body.

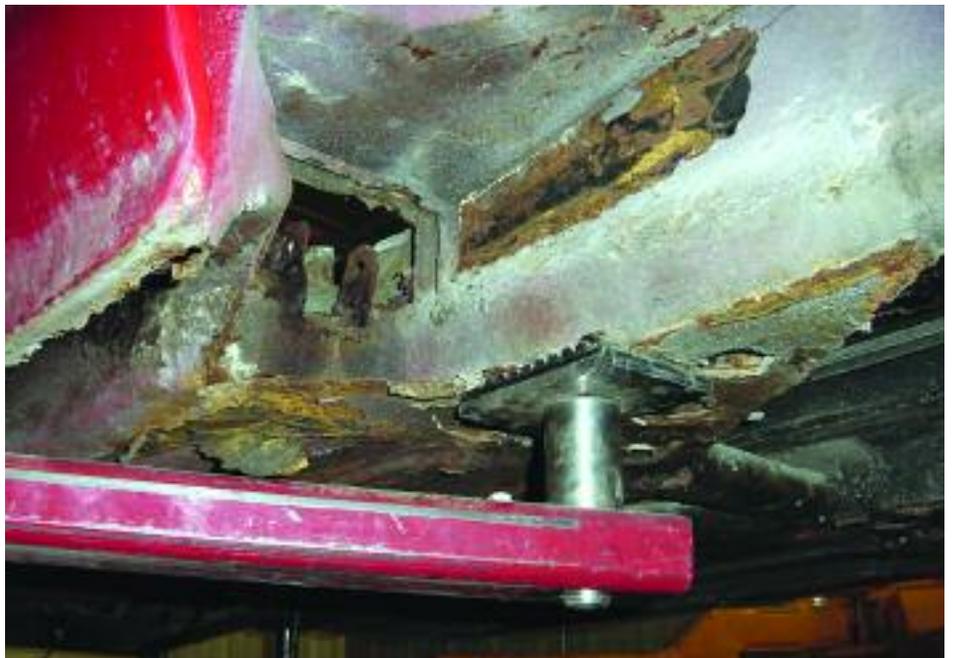
Rust in sill to floor area.

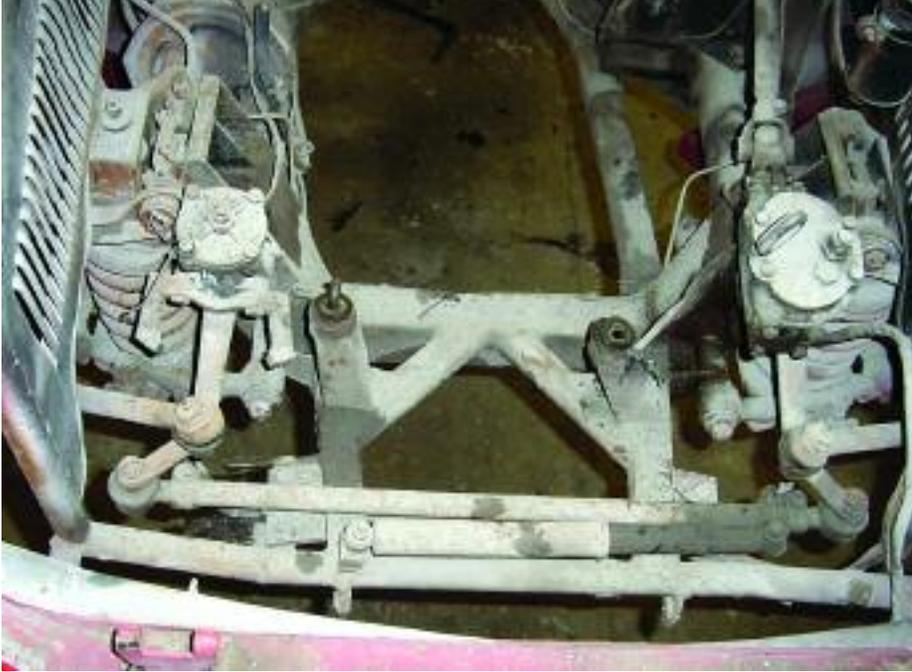
923 engine compartment revealing remarkable undamaged condition.

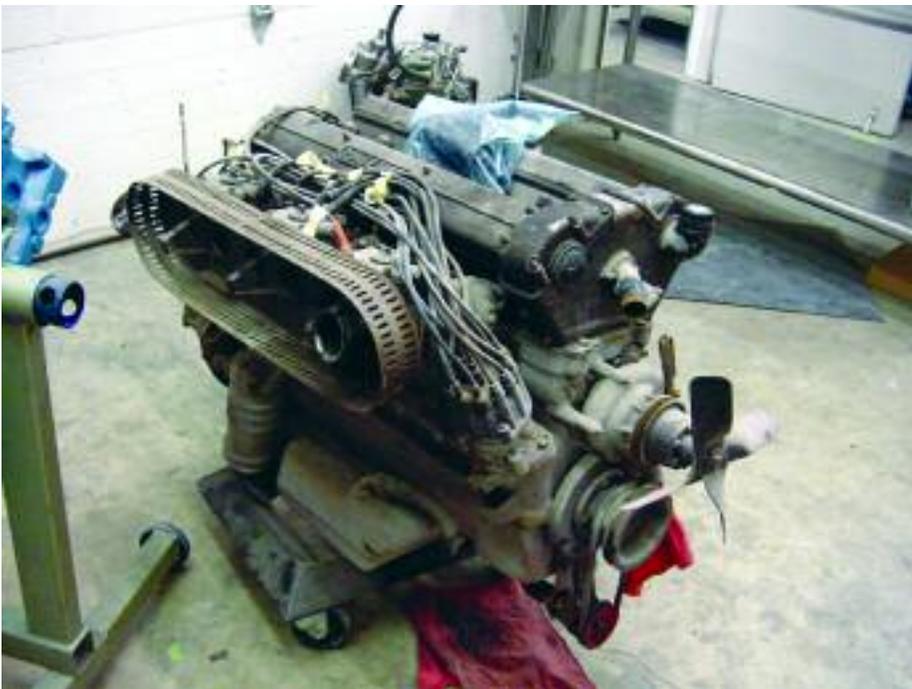
923's original engine prepared for inspection and technical evaluation prior to complete rebuild.

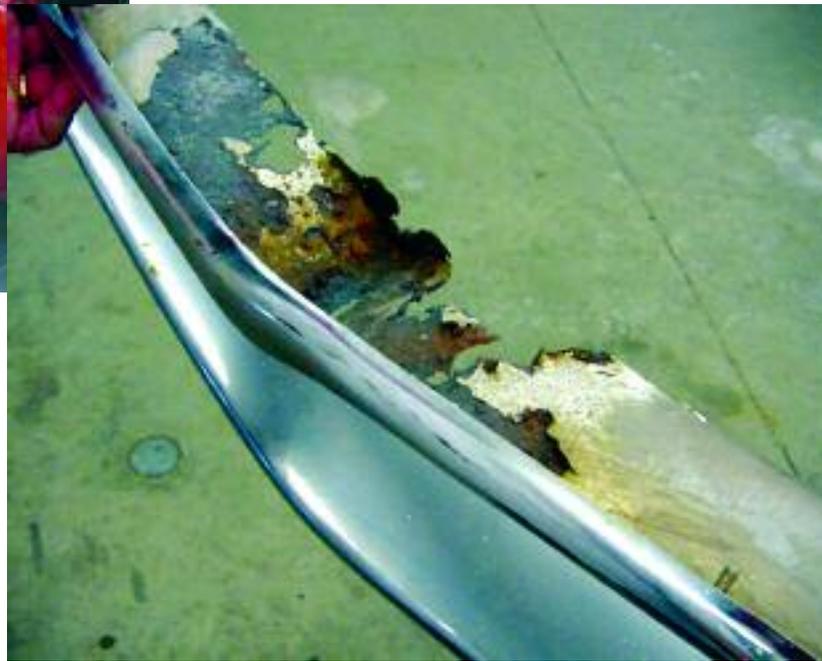
Front grill shell found to be the only trim piece in need of significant repair.

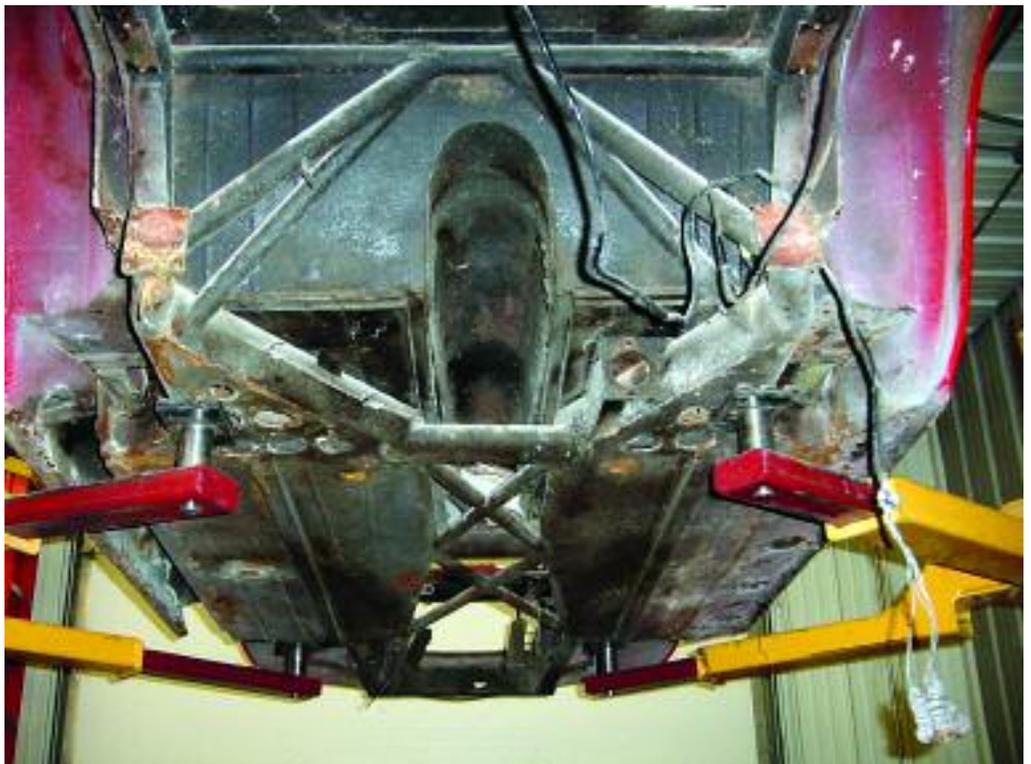
Although we found significant rot and corrosion in the rear lower body and outer structure, we found plenty of good news as it relates to the rest of the primary chassis and forward structure. We also found the remaining outer skin had not suffered significant rot or collision damage. As with the rear of the car, we will continue to remove the forward body skin, and proceed with the complete restoration process.

Primary chassis and forward structure found in remarkably solid condition.
