Maserati Rinato

1960 Maserati 3500 Vignale Spyder (vin #101-923) (Number 2/243 production)

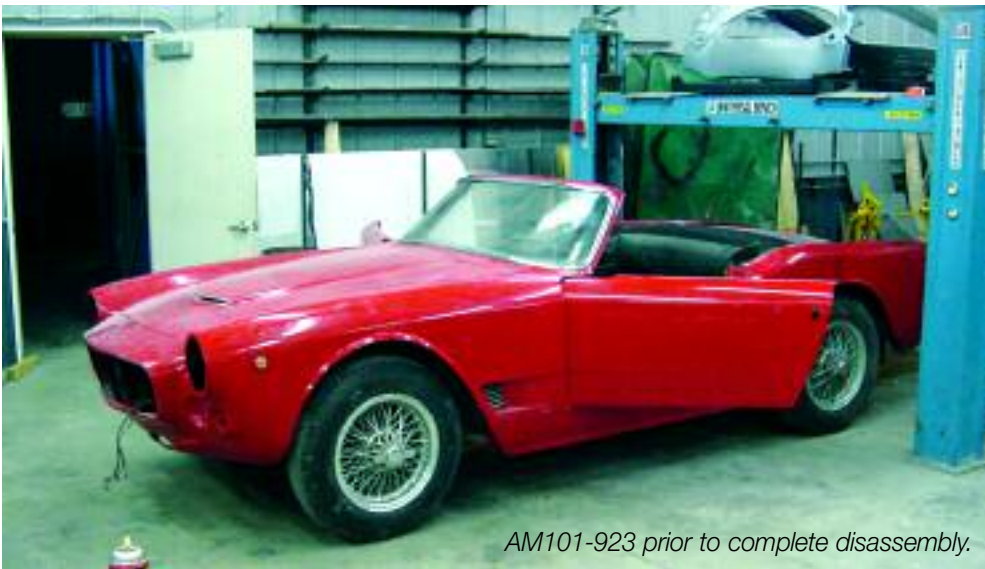
AM101-923 prior to complete disassembly.

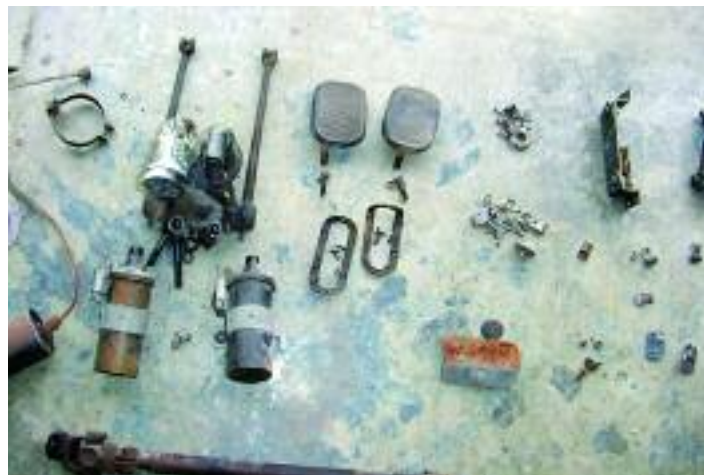
Additional 923 component photo inventory and inspection.

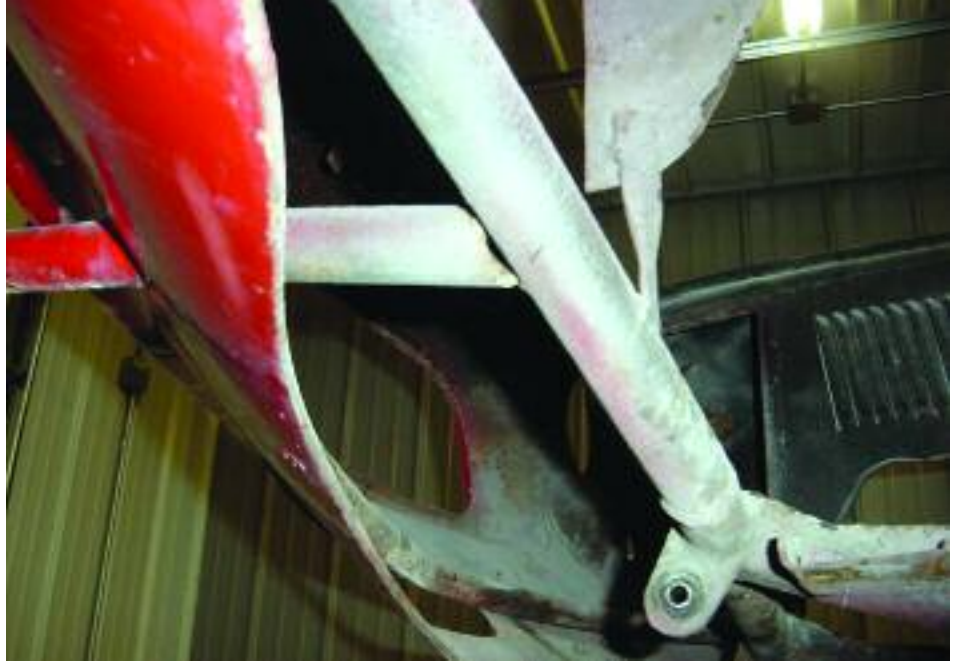
During the disassembly process we discovered a number of areas with incomplete welds and jiggling. This is common in low production hand-built cars; our approach is to enhance the structural integrity of the automobile where necessary, while retaining its originality and authenticity.

Front bumper frame extension only partially welded from the factory.

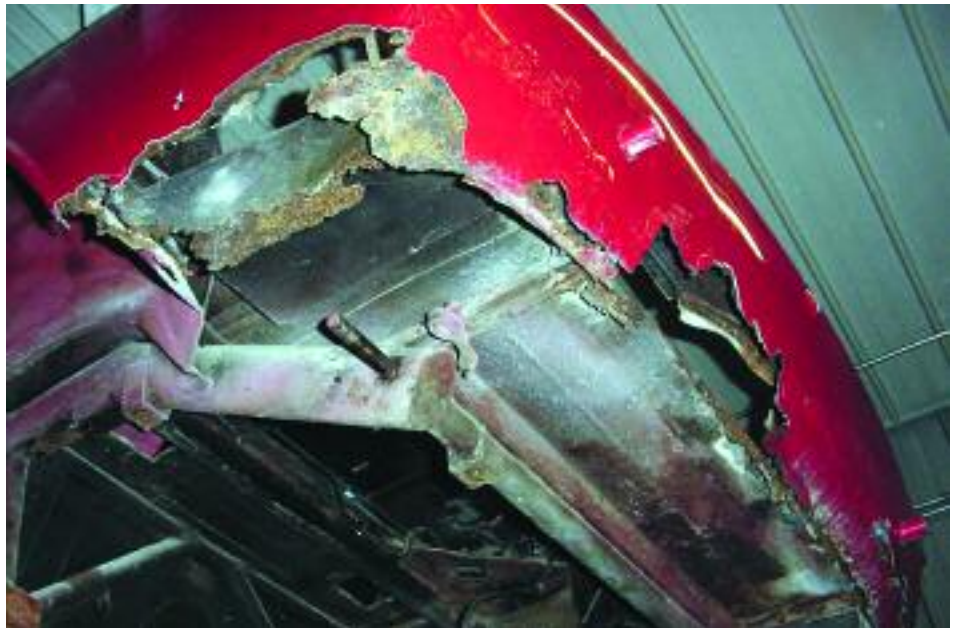
Some of our initial discoveries were the severe rot and corrosion on the entire rear lower body and outer structure. Once the body skin has been removed from the tubular chassis, the body skin will be chemically dipped and the tubular structure will be sand blasted. This process will allow our fabrication team to completely inspect, jig, and repair/replace all area affected by rust and corrosion.

Evidence of serious rot and corrosion damage in rear structure/body.

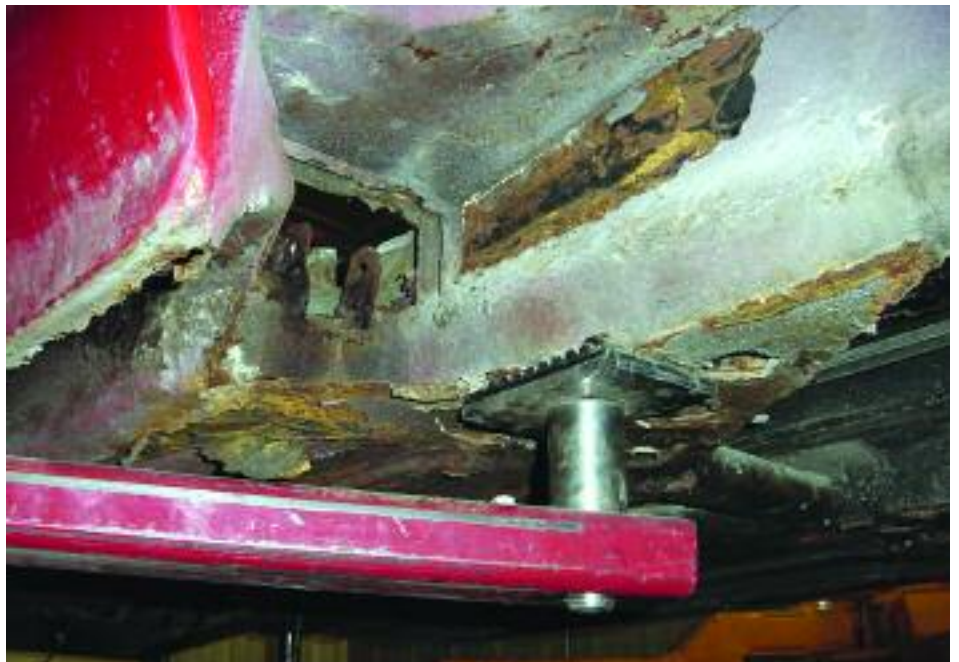
Rust in sill to floor area.

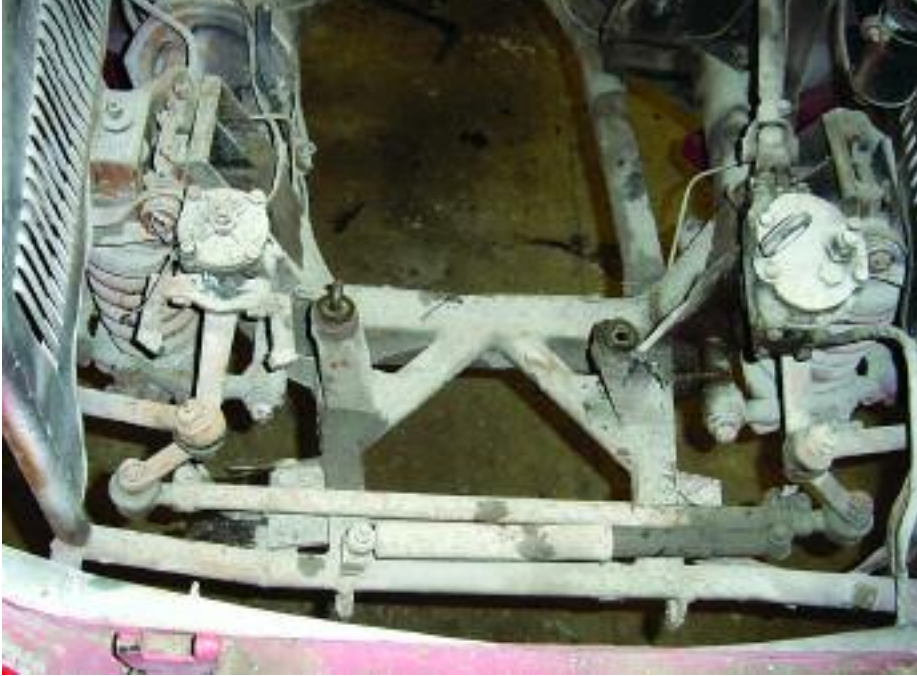
923 engine compartment revealing remarkable undamaged condition.

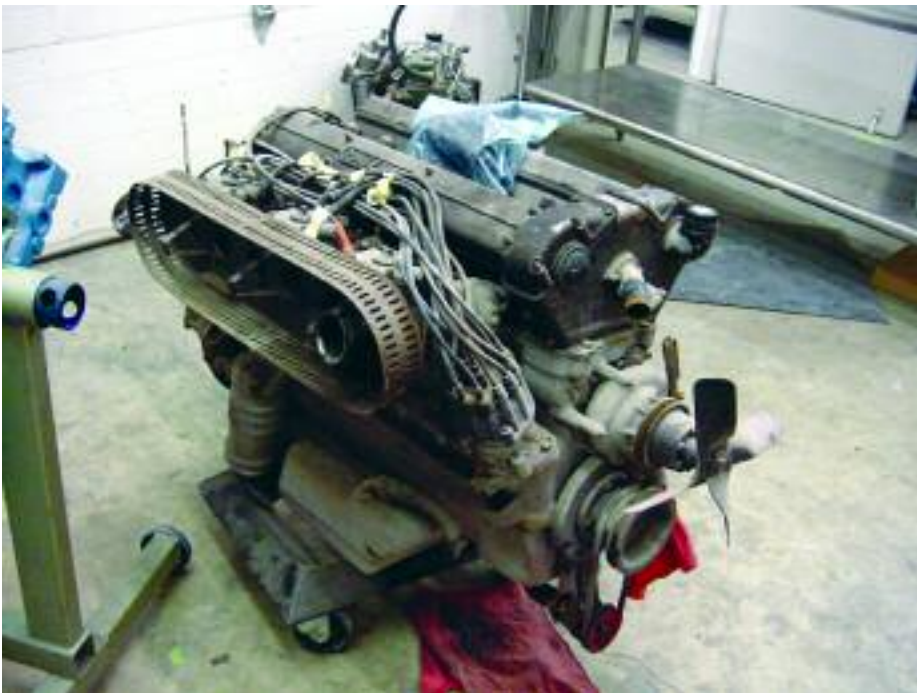
923's original engine prepared for inspection and technical evaluation prior to complete rebuild.

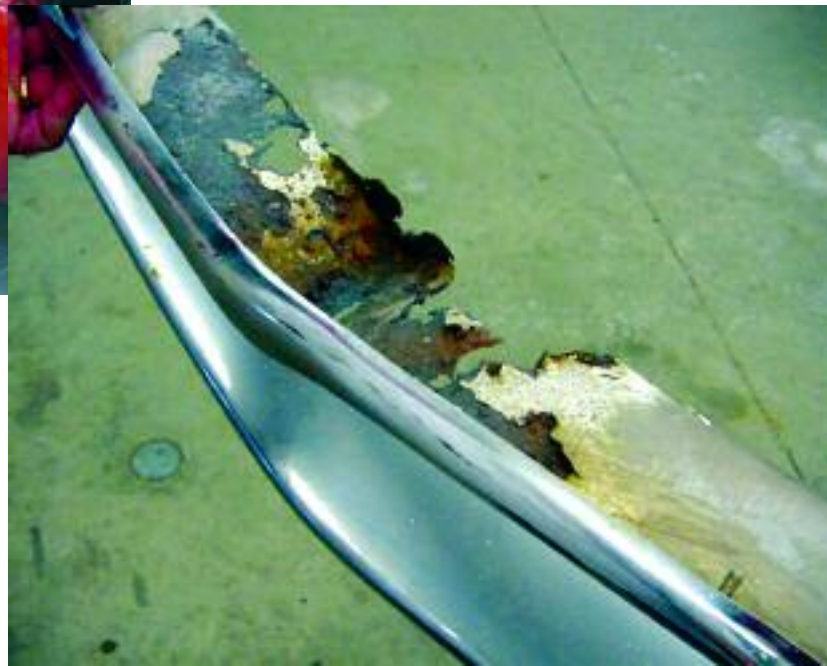
Front grill shell found to be the only trim piece in need of significant repair.

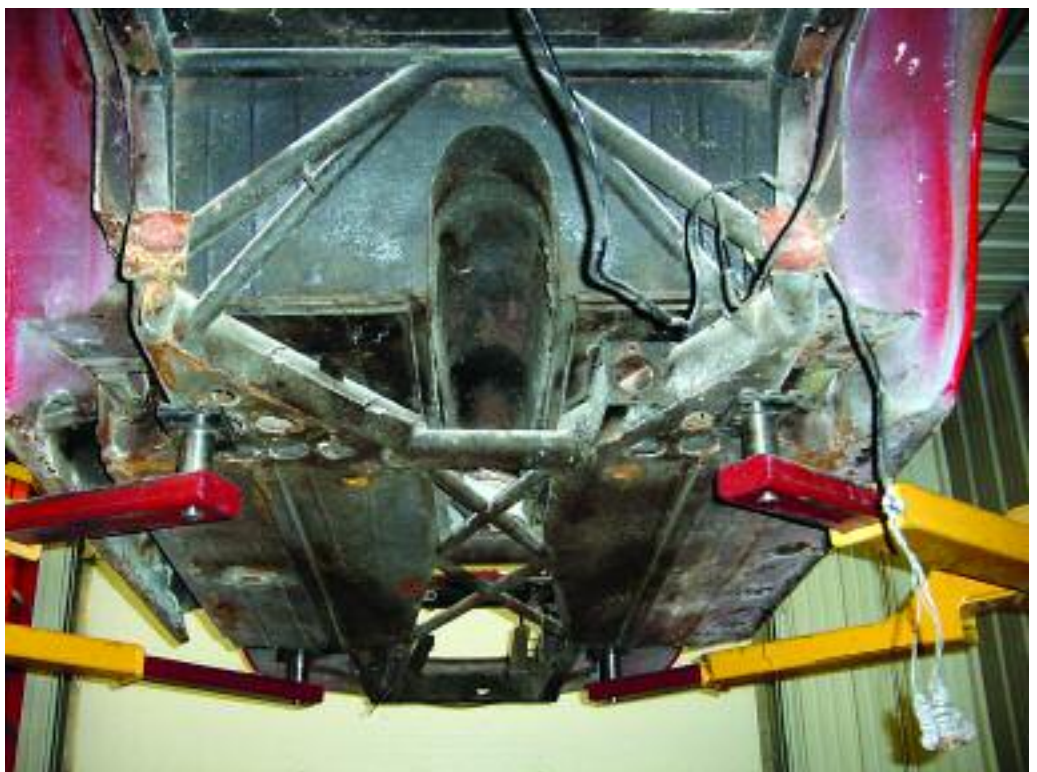
Although we found significant rot and corrosion in the rear lower body and outer structure, we found plenty of good news as it relates to the rest of the primary chassis and forward structure. We also found the remaining outer skin had not suffered significant rot or collision damage. As with the rear of the car, we will continue to remove the forward body skin, and proceed with the complete restoration process.

Primary chassis and forward structure found in remarkably solid condition.
