The Healey Werks

Maserati Rinato

1960 Maserati 3500 Vignale Spyder

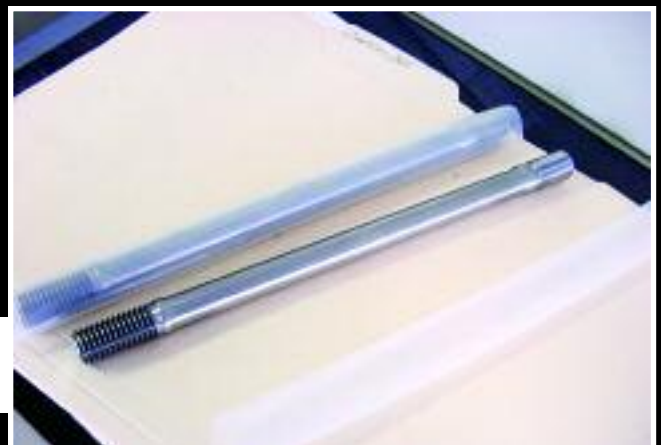
Picture showing new and available head stud.

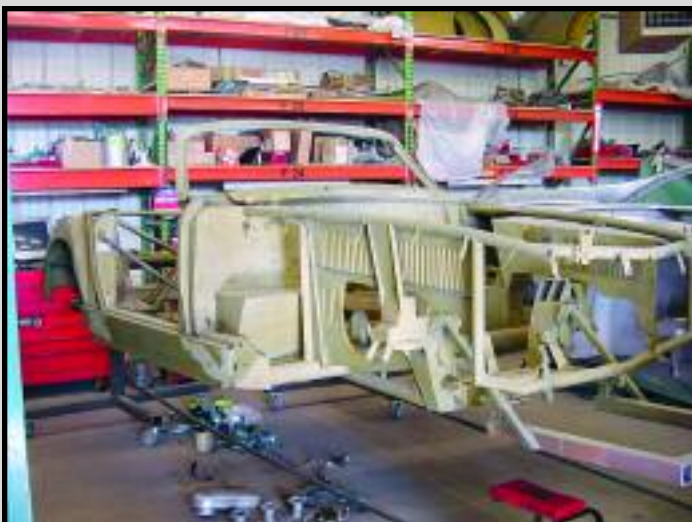
Chassis after assessment and light coat of etch prime to keep from flash rusting.

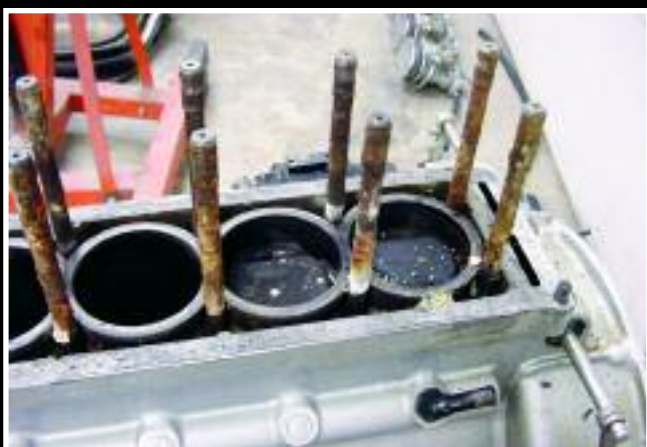
All fasteners have what is called torque yield limit. Simply, this means that a fastener will yield a given amount of stretch and repetition before it has become over-stretched, leading to the fastener failing. Age and stress also play a critical part in the life of a fastener, as our engines age, so do the fasteners that hold them together. Add the constant load and stress given to the cylinder head studs, connecting rod bolts, crankshaft, and main cap studs and it is a recipe for catastrophic engine failure.

Severe pitting and corrosion coupled with age will surely lead to head stud and engine failure of reused.

However it is rare when fasteners are replaced. Let's be clear, I do not feel it is necessary to replace all fasteners, but a few critical groups do exist and at the minimum these should be strongly considered for replacement.

- 1) head studs
- 2) connecting rod bolts and nuts
- 3) main studs and nuts
- 4) flywheel bolts and nuts

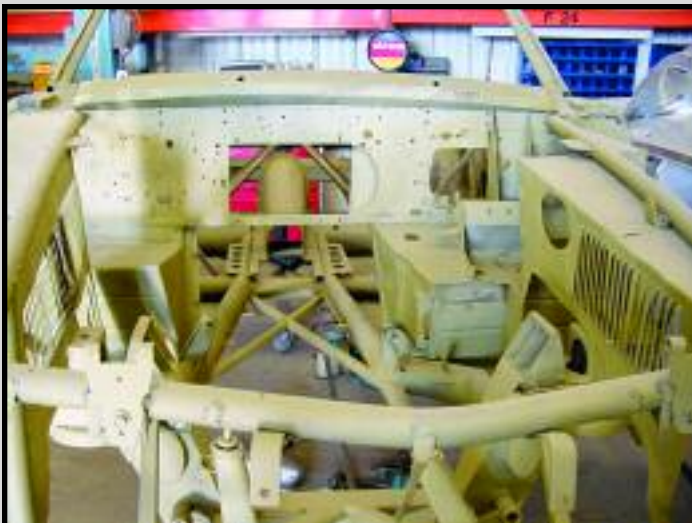
Showing excellent condition of engine compartment and front structure.

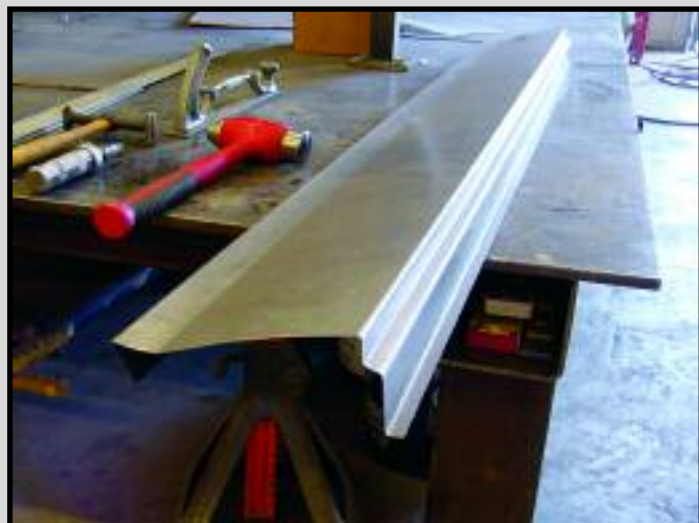
Newly fabricated rocker panel assembly.

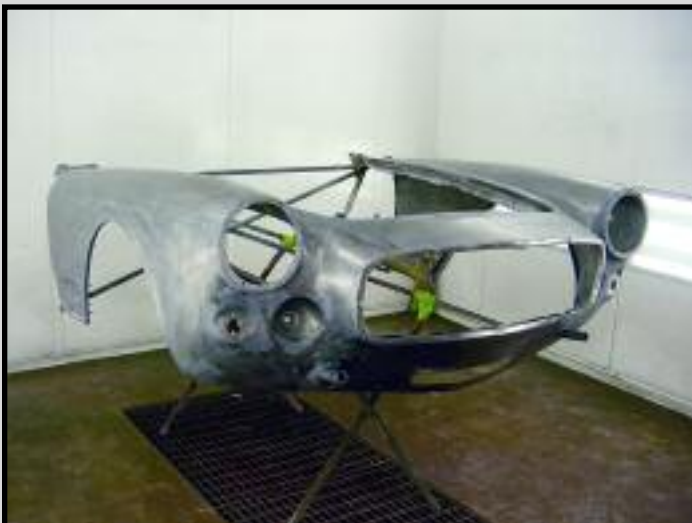
Front nose section with all metal work and straightening completed.

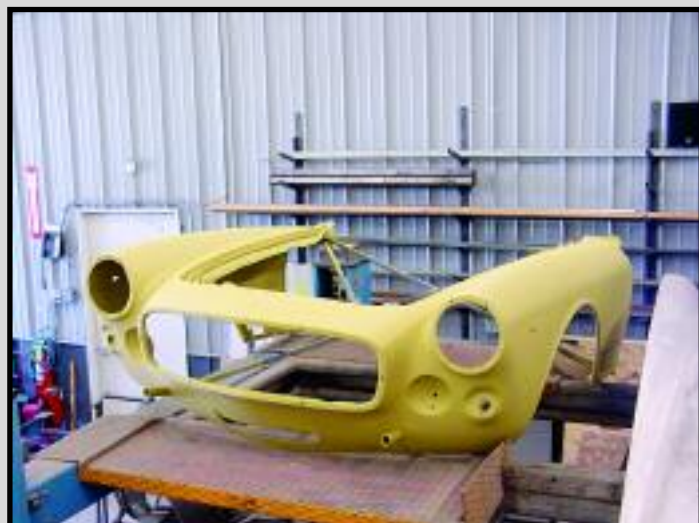
Nose assembly after primer coat ready for re-installation.

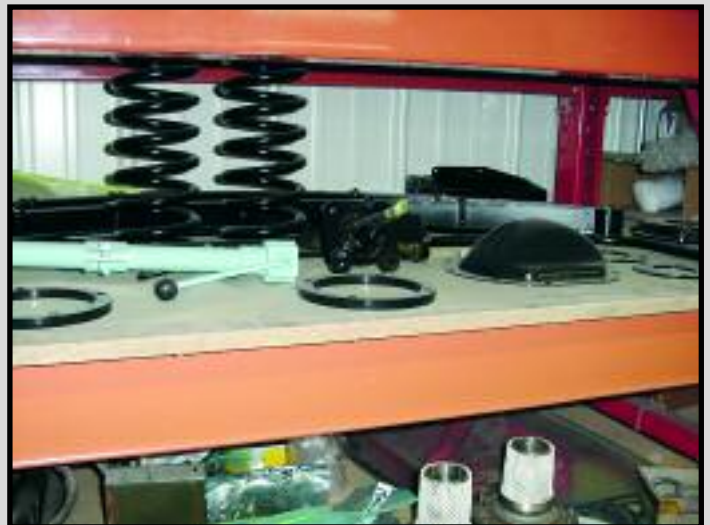
Various parts safely stored on designated shelving, awaiting final fitting.

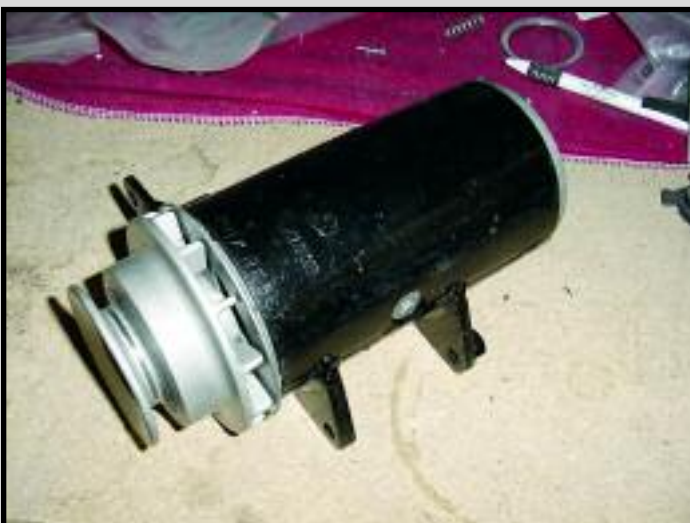
Original Marelli Dynamo after full rebuild, including field coil and armature rewind.
