The Healey Werks

Maserati Rinato

1960 Maserati 3500 Vignale Spyder

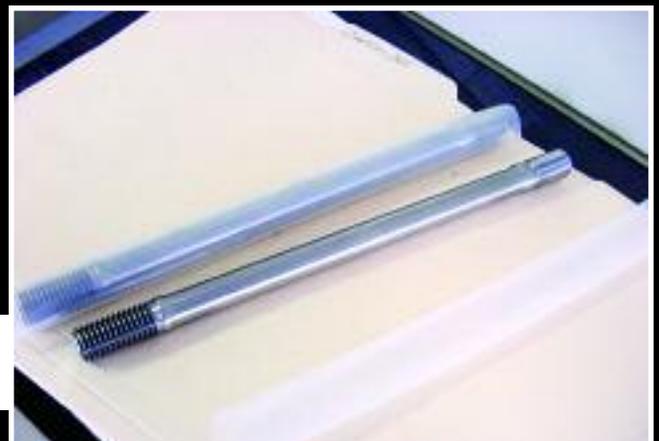
Picture showing new and available head stud.

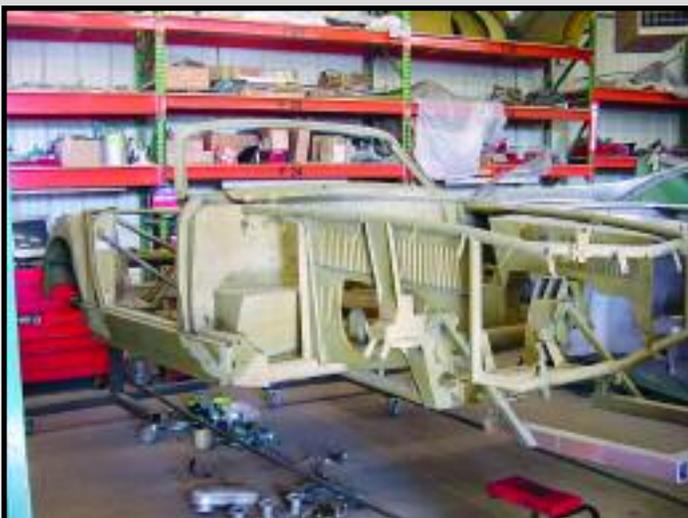
Chassis after assessment and light coat of etch prime to keep from flash rusting.

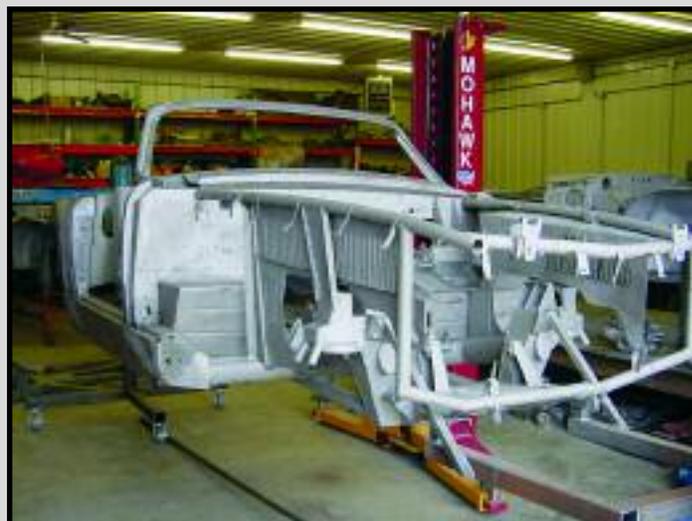
Chassis after sandblast.

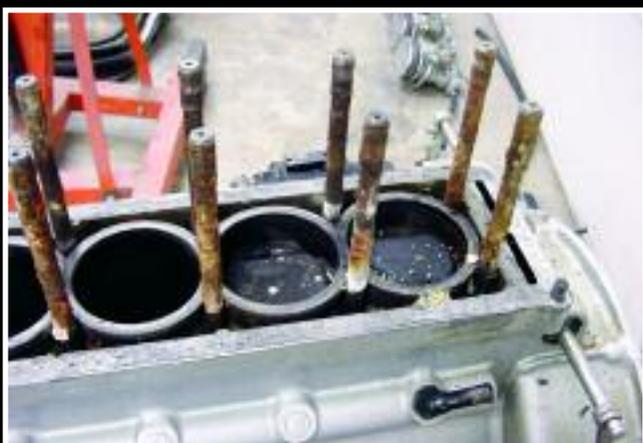
Severe pitting and corrosion coupled with age will surely lead to head stud and engine failure of reused.

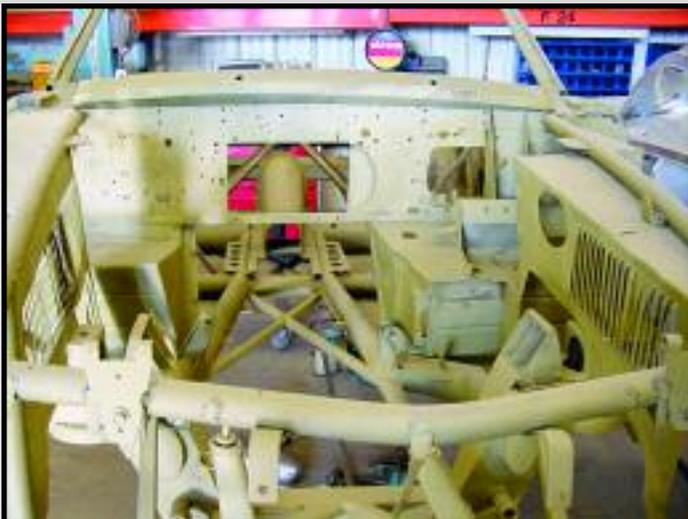
Showing excellent condition of engine compartment and front structure.

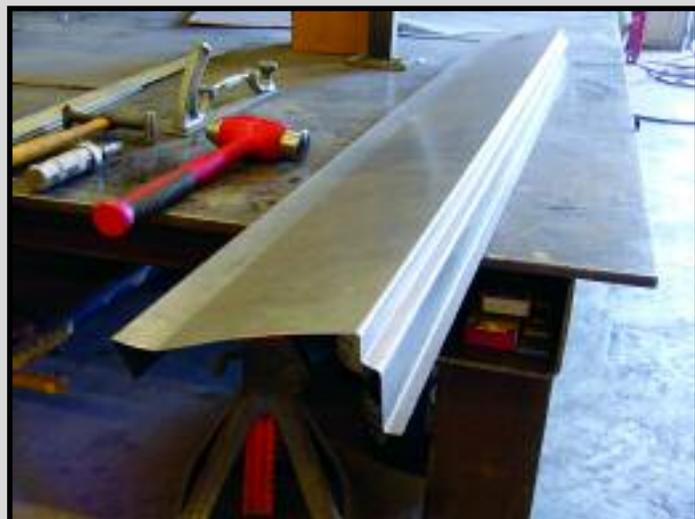
Newly fabricated rocker panel assembly.

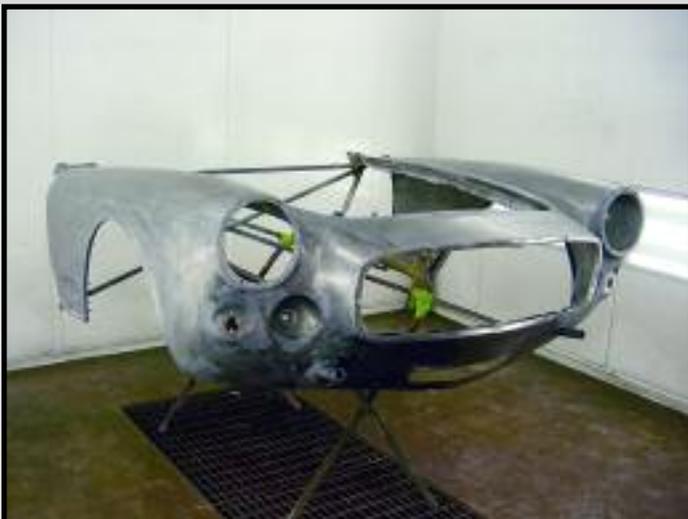
Front nose section with all metal work and straightening completed.

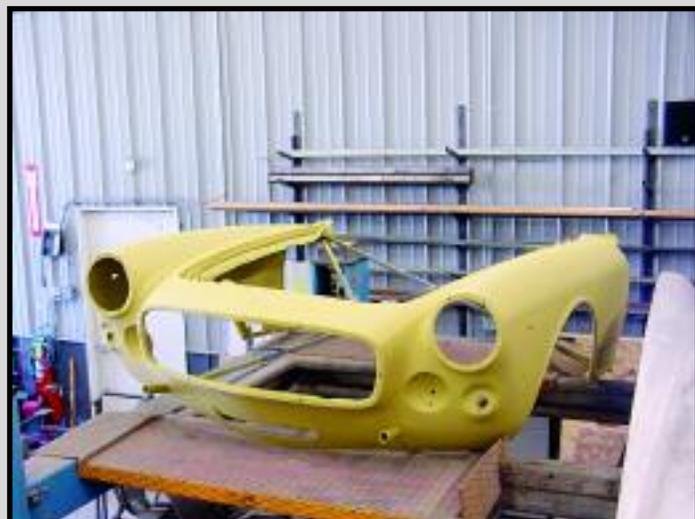
Nose assembly after primer coat ready for re-installation.

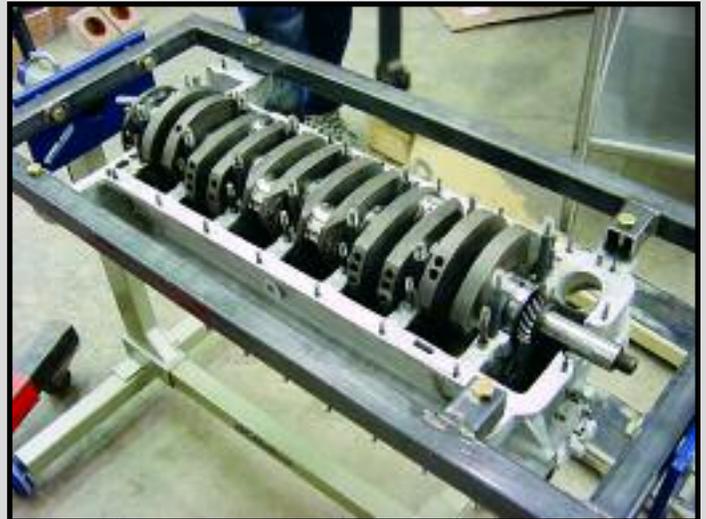
Beginning of engine reassembly.

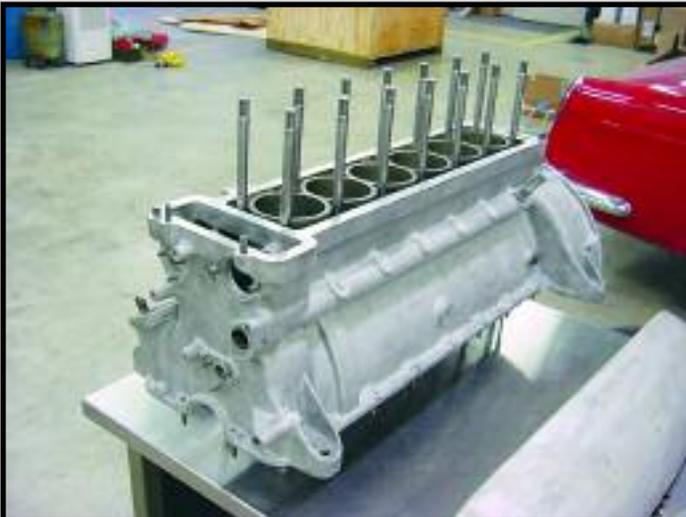
Showing prepared engine block.

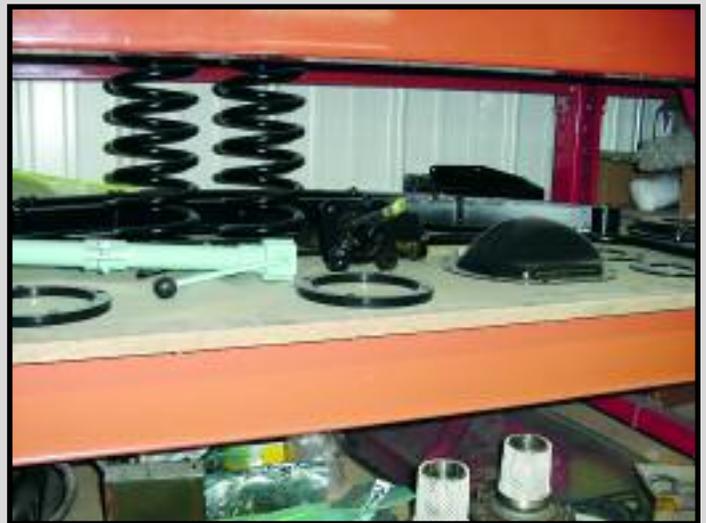
Various parts safely stored on designated shelving, awaiting final fitting.

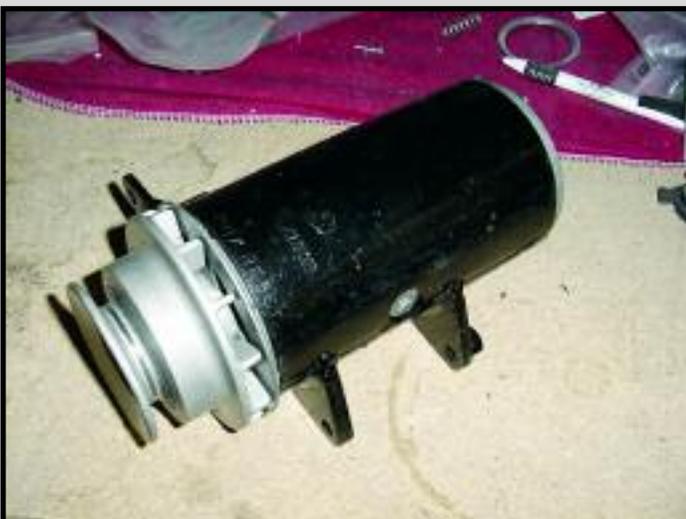
Original Marelli Dynamo after full rebuild, including field coil and armature rewind.
