The Healey Werks

Maserati Rinato

1960 Maserati 3500 Vignale Spyder

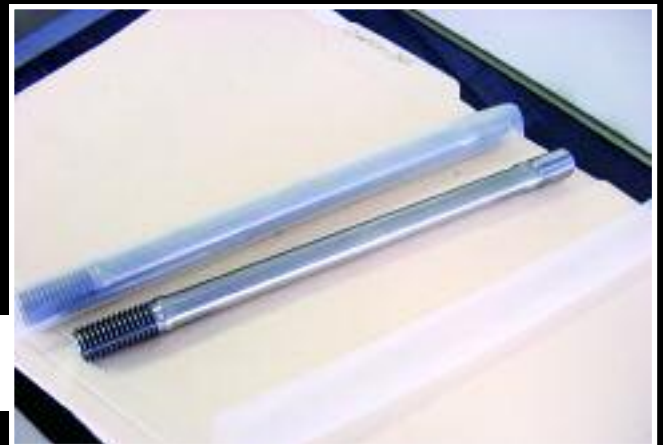
Picture showing new and available head stud.

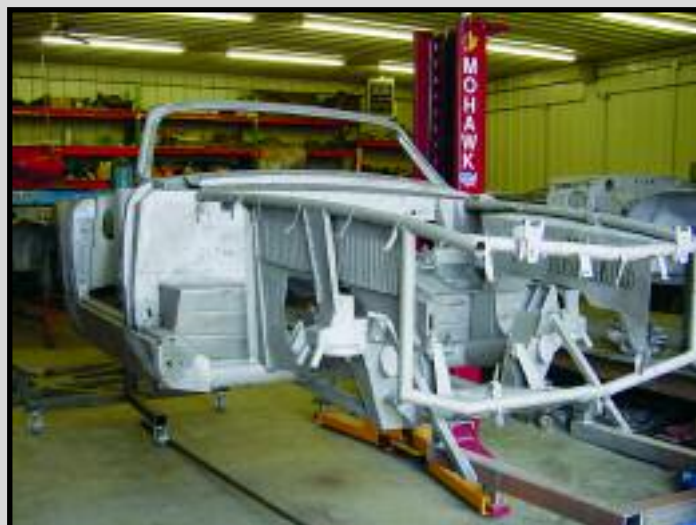
Chassis after sandblast.

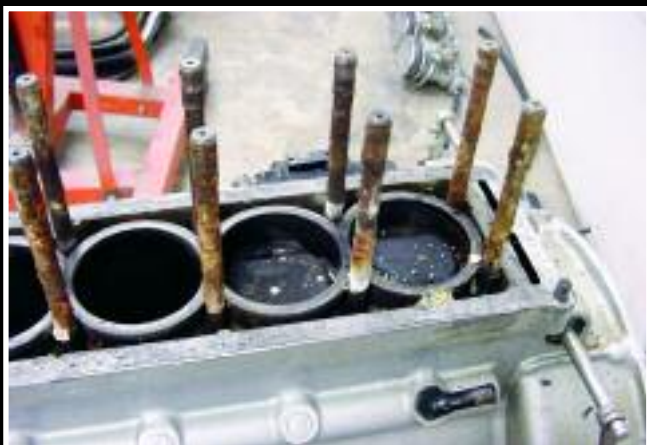
All fasteners have what is called torque yield limit. Simply, this means that a fastener will yield a given amount of stretch and repetition before it has become over-stretched, leading to the fastener failing. Age and stress also play a critical part in the life of a fastener, as our engines age, so do the fasteners that hold them together. Add the constant load and stress given to the cylinder head studs, connecting rod bolts, crankshaft, and main cap studs and it is a recipe for catastrophic engine failure.

Severe pitting and corrosion coupled with age will surely lead to head stud and engine failure of reused.

The reasons these parts must be replaced include age, stress, and specification.

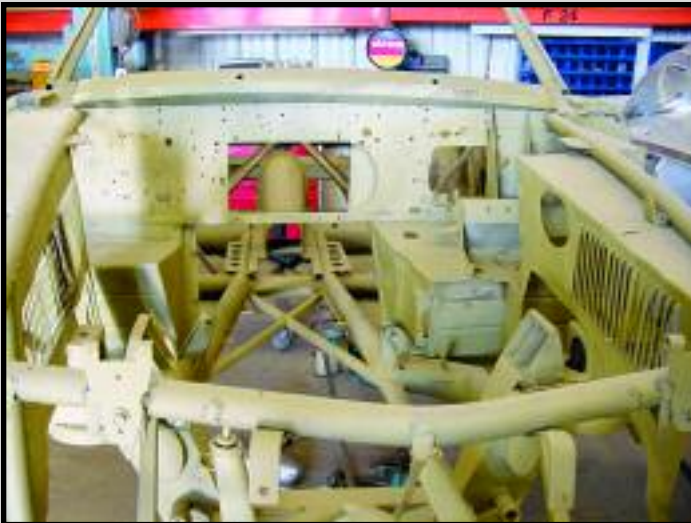
Showing excellent condition of engine compartment and front structure.

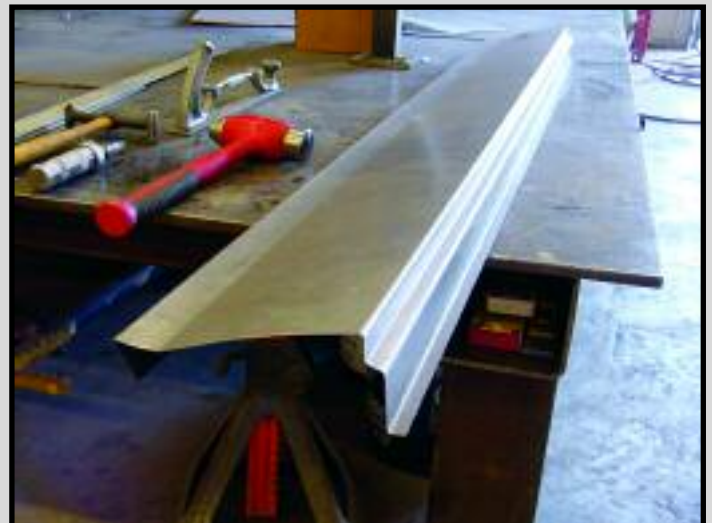
Newly fabricated rocker panel assembly.

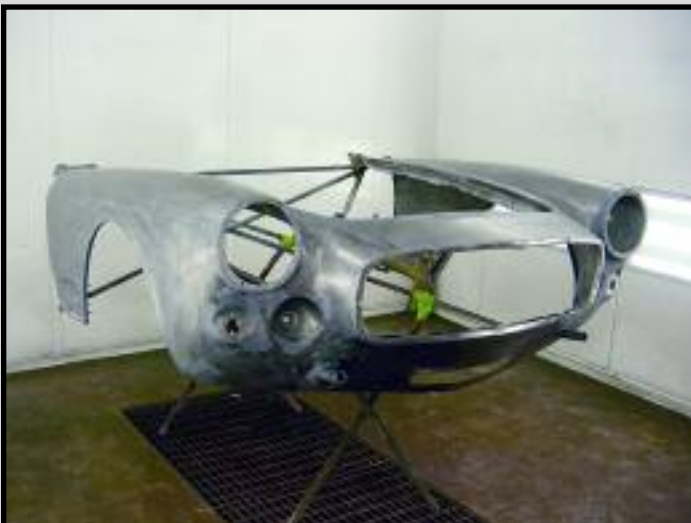
Front nose section with all metal work and straightening completed.

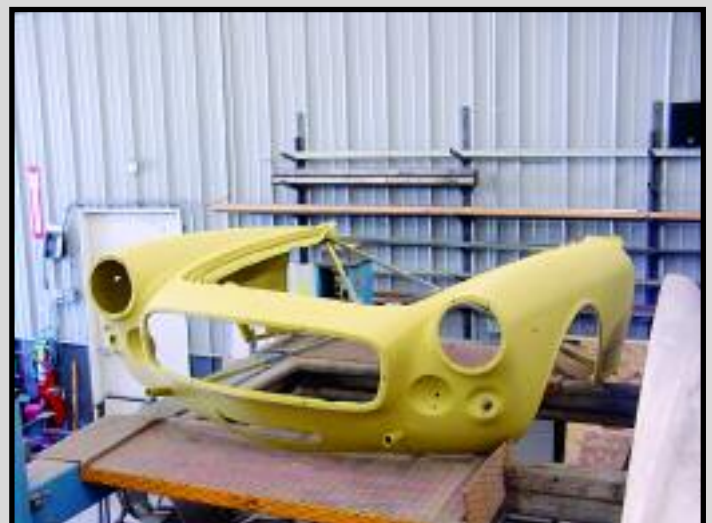
Nose assembly after primer coat ready for re-installation.

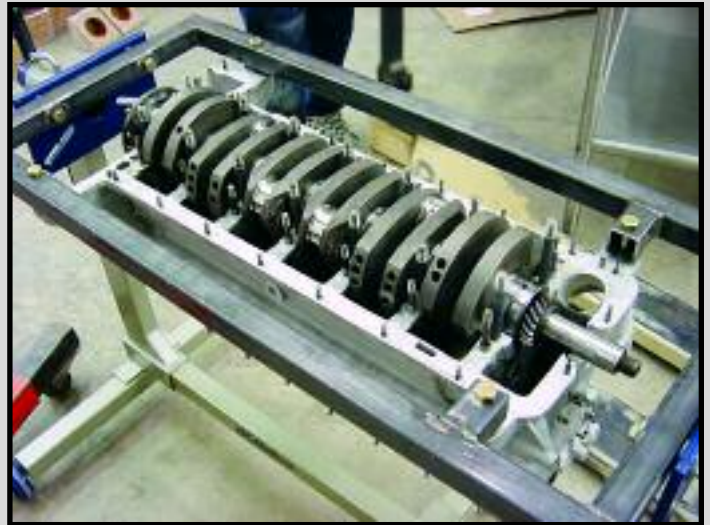
Beginning of engine reassembly.

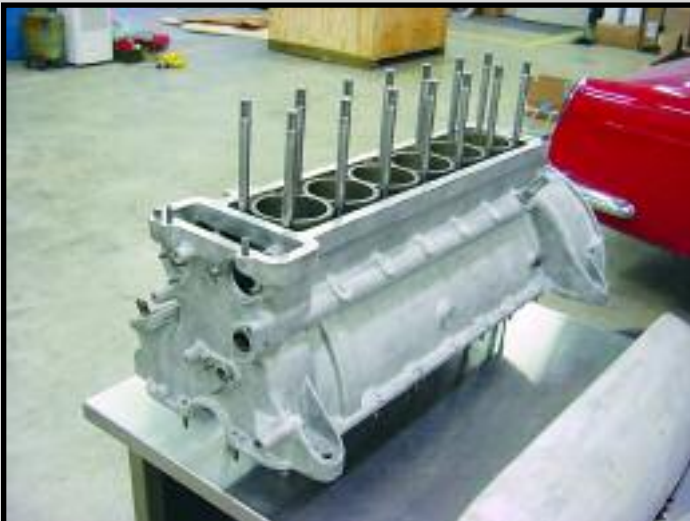
Showing prepared engine block.

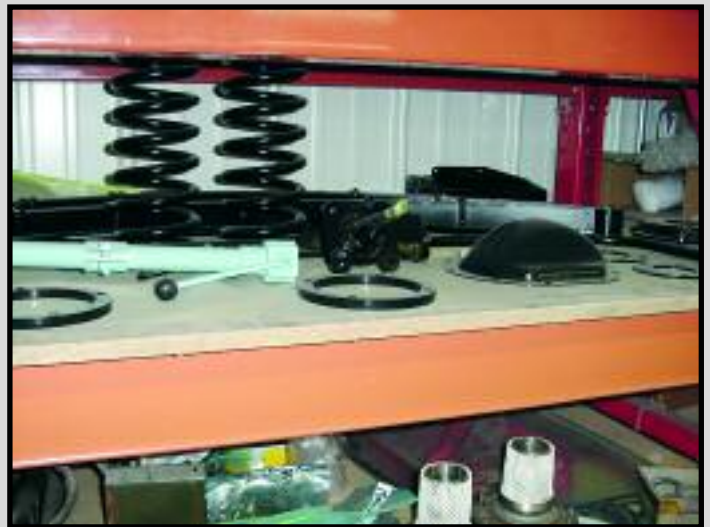
Various parts safely stored on designated shelving, awaiting final fitting.
