The Healey Werks

Maserati Rinato

1960 Maserati 3500 Vignale Spyder

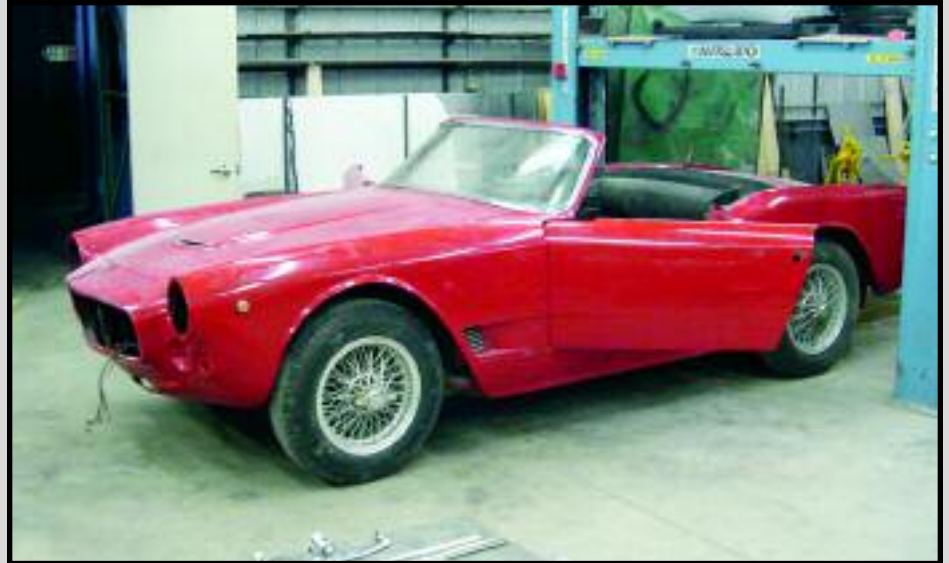
In our initial investigation of the history of this specific car, we found that it was sold to the first owner on June 13, 1960 with body number: 30. This vehicle was originally painted Rosso Alfa with nero leather interior. We are continuing to investigate the full history of 923 and hope to update this information in the next issue of *Viale Ciro Menotti*.
