HEALEYWERKS RESTORATIONS

We thought it would be interesting to follow select Maserati restorations. This is the first in a series documenting the restoration of a 1963 Sebring being professionally restored by Healey Werks in Lawton, Iowa. We have seen an upsurge in top-quality Maserati restorations, especially on the six-cylinder cars. You will be able to follow this restoration in *Viale Ciro Menotti*, on the maseratinet.com Web site and on healeywerks.com Web site. This will allow us to see the detail that goes into a restoration of this magnitude, observe some of the typical challenges as they are discovered, and see how they are overcome. Check back occasionally to follow the progress.

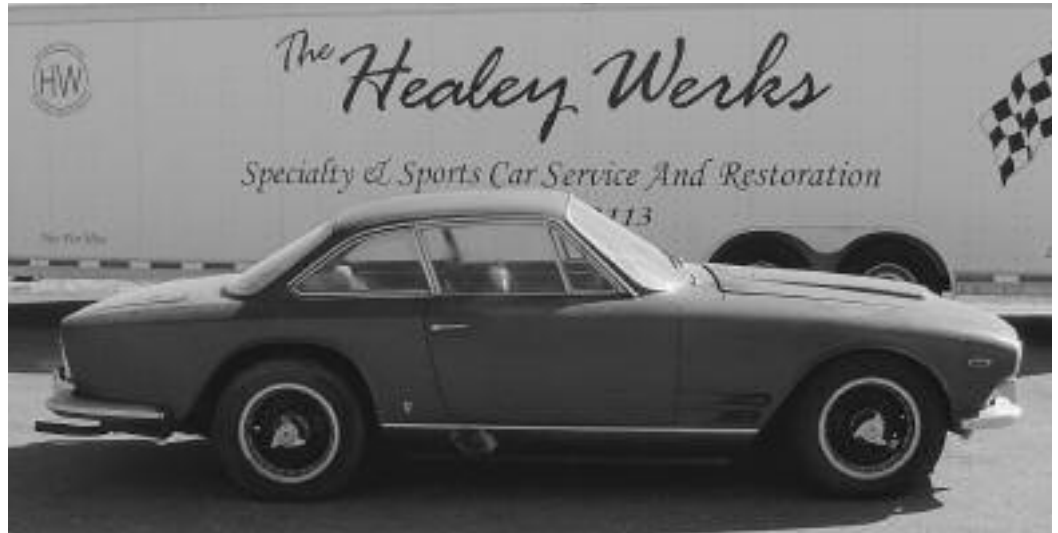
Borrani wire wheels were typical on the Sebring. You can tell this is a series I Sebring by the vents at the bottom of the fenders, the two-piece vertical taillights, and the front light group, including 3500 GTI style turn signals. Series I headlight trim is "pinched" in the middle and there are no fog lamps. The Sebring was designed by Giovanni Michelotti while at Vignale to take Maserati's successful entrée into GT cars with the 3500, use the mechanicals and update the styling to offer an upscale 3500.

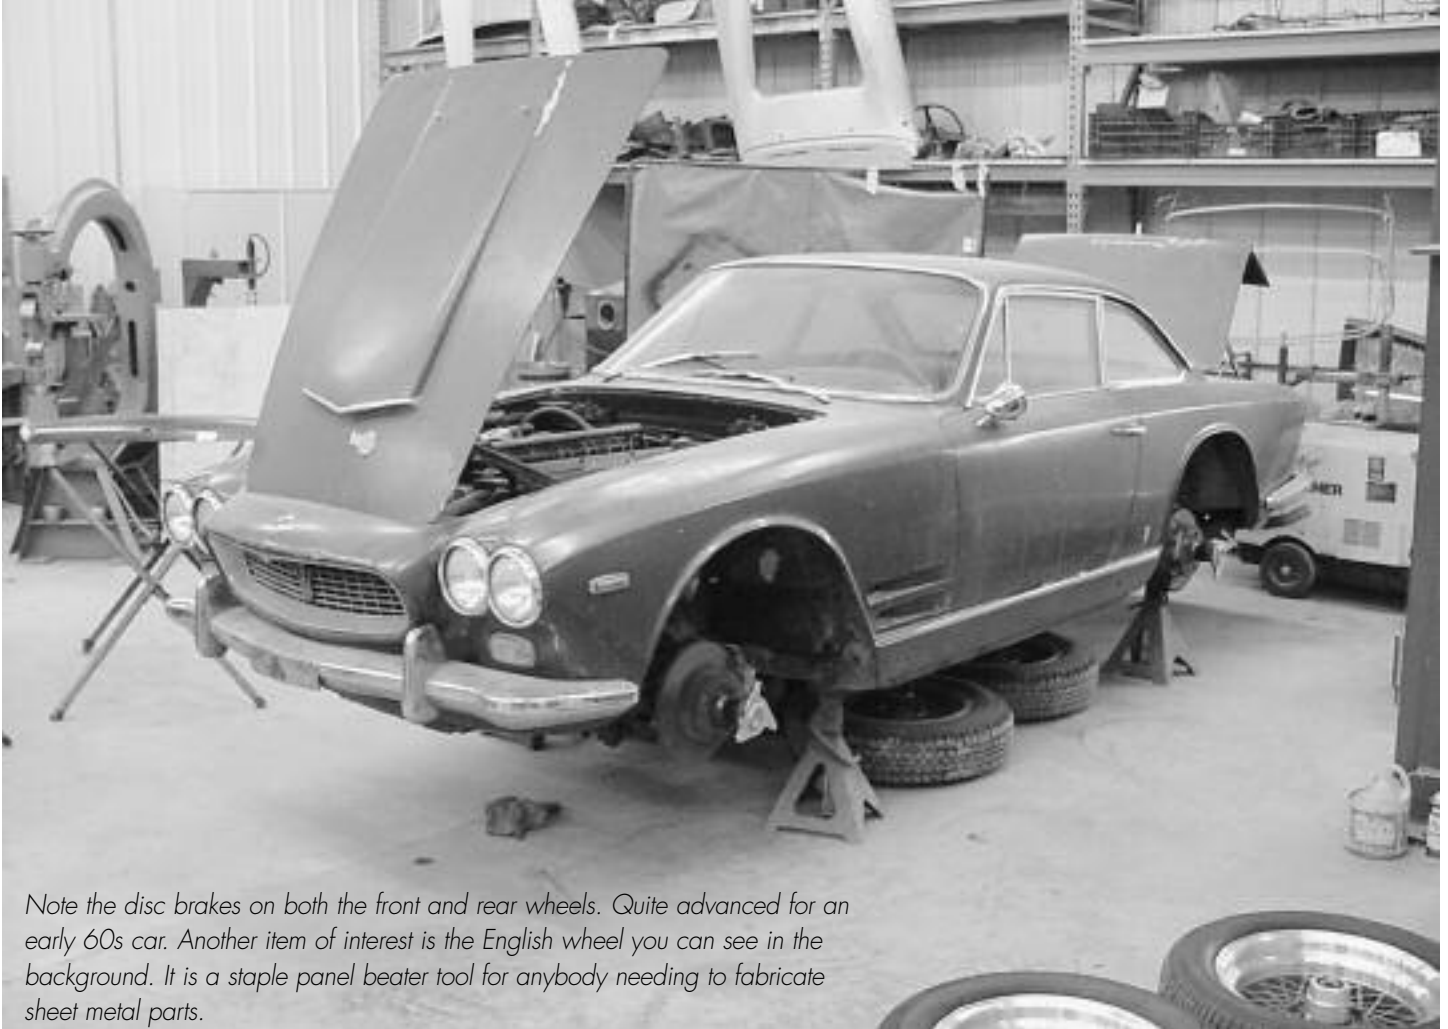
Note the disc brakes on both the front and rear wheels. Quite advanced for an early 60s car. Another item of interest is the English wheel you can see in the background. It is a staple panel beater tool for anybody needing to fabricate sheet metal parts.

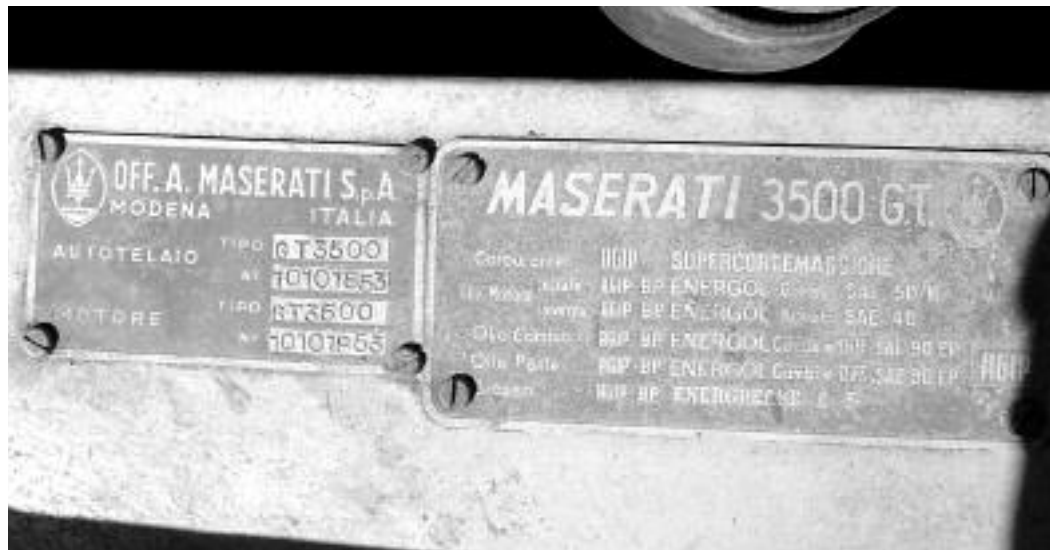
Note the Sebring data plate indicating a series one car by a serial number starting with 10101####.

Series II cars have a number starting with 101/10####. The 1963 model Sebrings were numbered between 1539 and 1879 (except 1793, which was produced in 1965 – go figure). Only odd numbers were used.

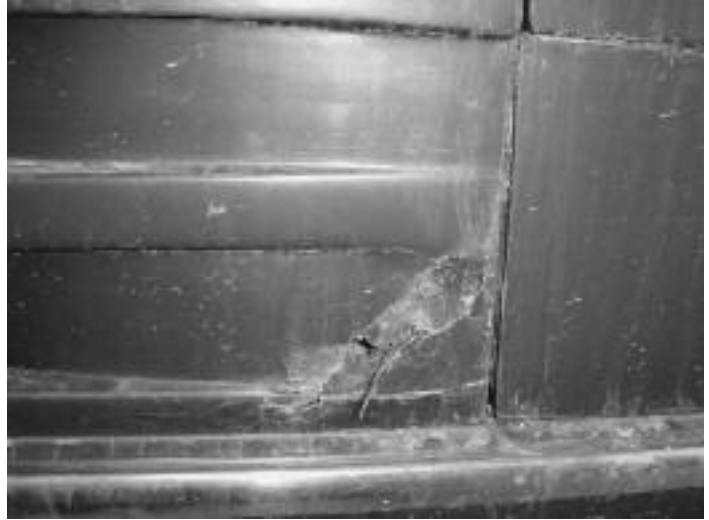
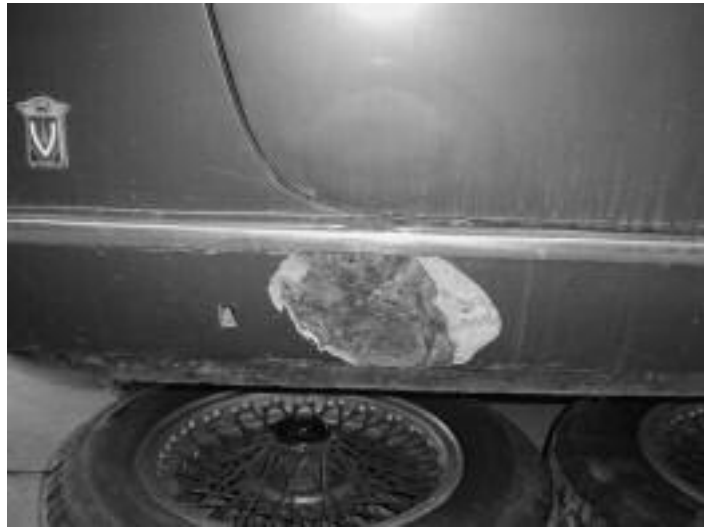
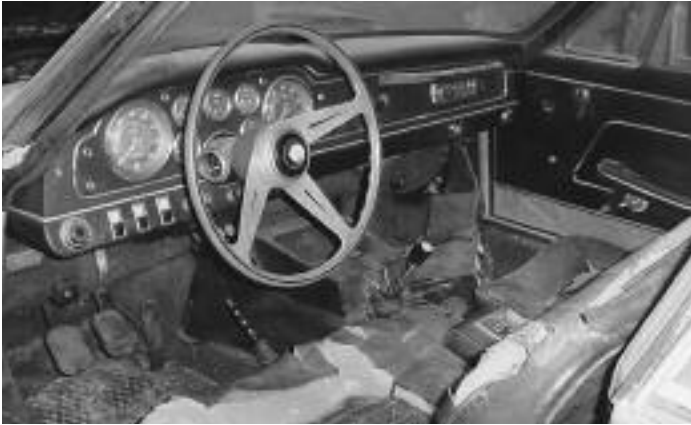
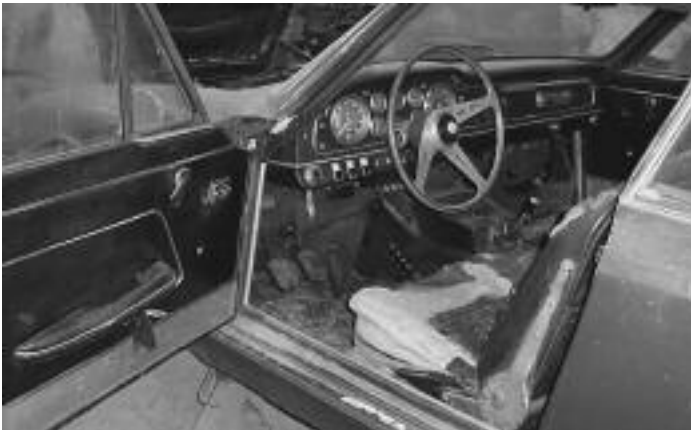
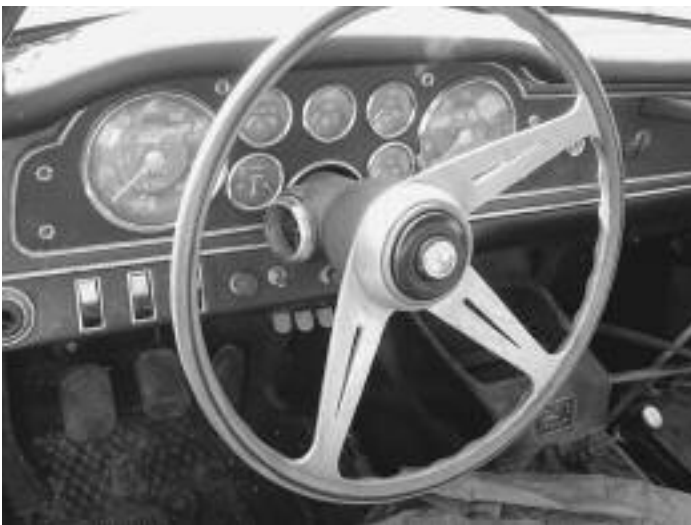
Although a California car, it still has managed to acquire some rust, mostly in the front and rear inner wheel housings and front fender vents. This car is very much a time capsule car, as the interior, mechanicals, body and paint are original. This makes this particular example a very desirable and exciting project for restoration. The rockers, floors, and most of the rest of the car remain solid. The car will receive a full disassembly and rotisserie restoration to the very highest standards. The body will be stripped to bare steel, then any corrosion and structural repairs will be carried out.

Left: Note the Nardi steering wheel – the same as was used on the Allemano 5000GT.

The interior seat, carpet, and interior panels will be rebuilt and duplicated as original. Every mechanical system and component will be thoroughly inspected, restored and rebuilt. We have acquired many NOS parts to make the restoration much more accurate. However, many parts are no longer obtainable and will require fabrication and replication in-house. **(Publisher's comment:** *I can recommend a great source where you can find huge inventory of Maserati parts available for same-day shipping.*)

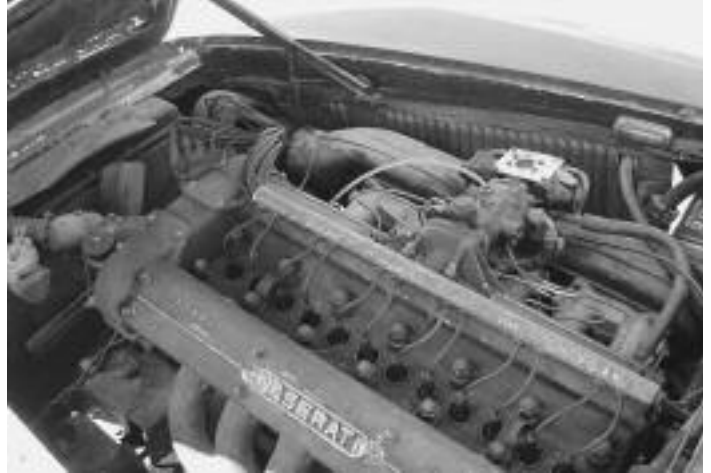
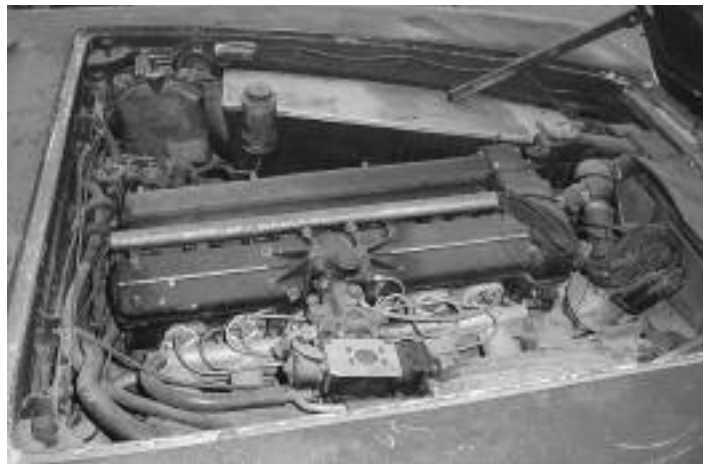
Note the original, intact, Lucas fuel injection system still on this car.
