Healey Werks Restoration 101

Article and photos courtesy of Craig Hillinger, Healey Werks

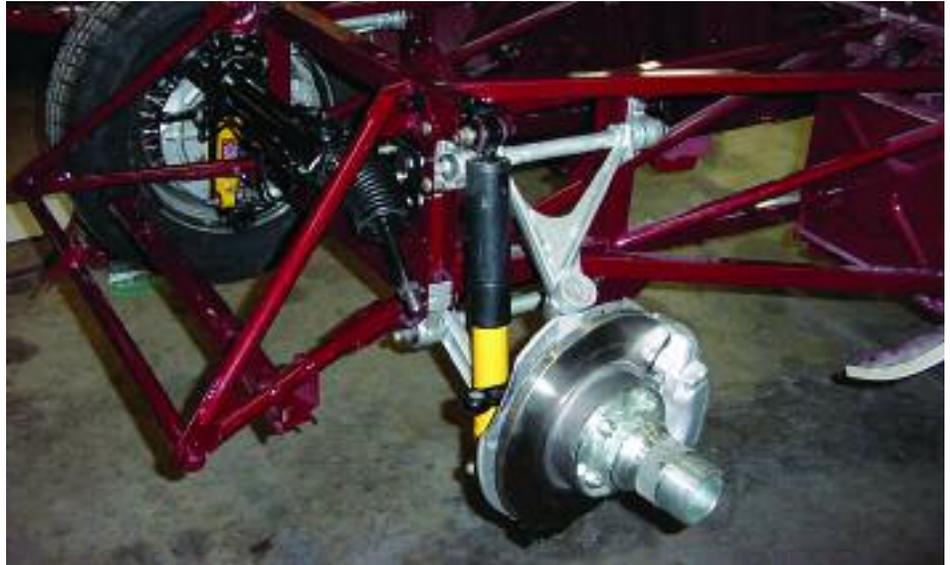
E Type Jaguar Suspension assembly.

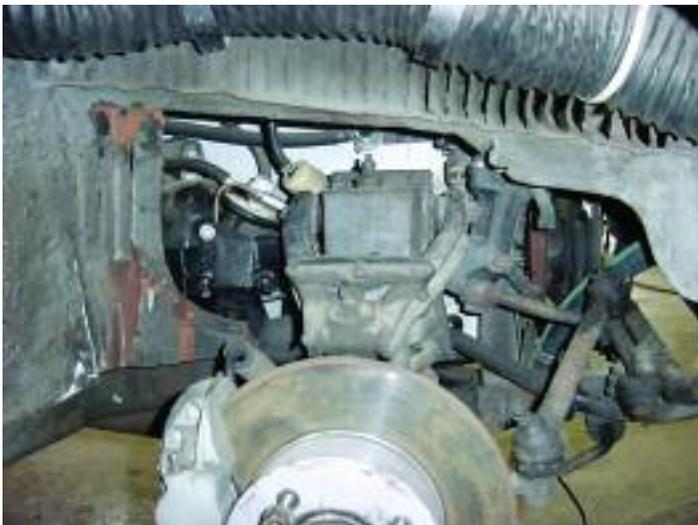
Maserati 3500 right front suspension before disassembly.

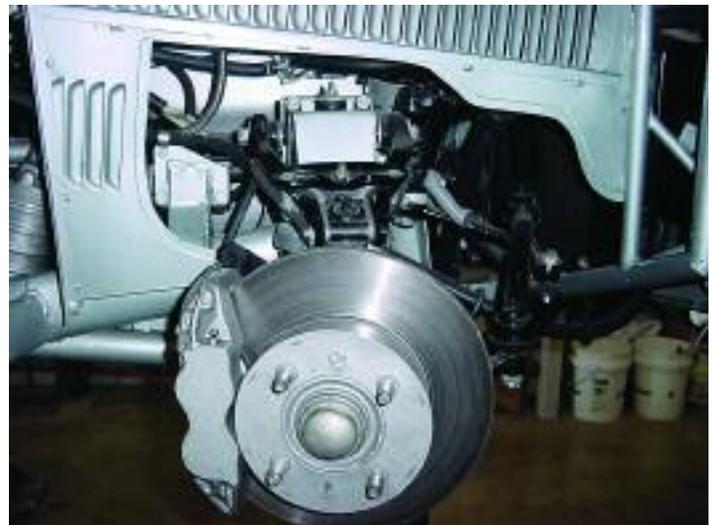
3500 after reassembly.

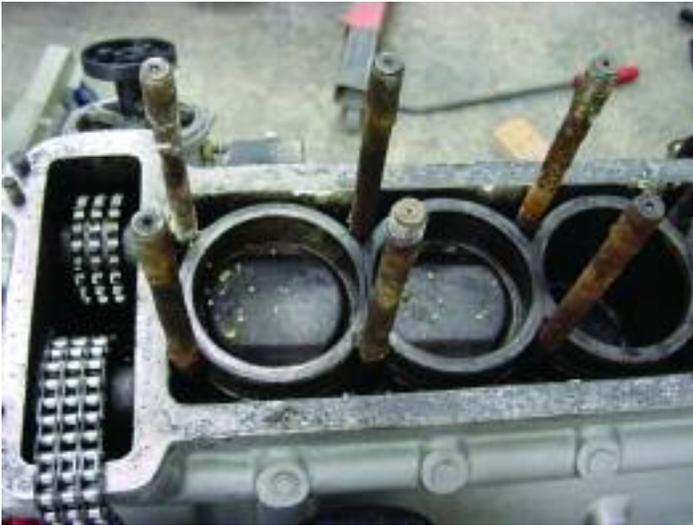
Maserati 3500 Engine in disassembly process.

Now that the car is disassembled, all of the components are now addressed. First, the suspension, steering, brakes, and related driveline components are disassembled, checked for stress fatigue, cracks wear or any other damage. The engine and transmission are also

stripped and checked for wear, component failure, or any other problem that may exist. Once this step has been completed, the engine components can then go to the machining process and be brought to tolerances for reassembly.

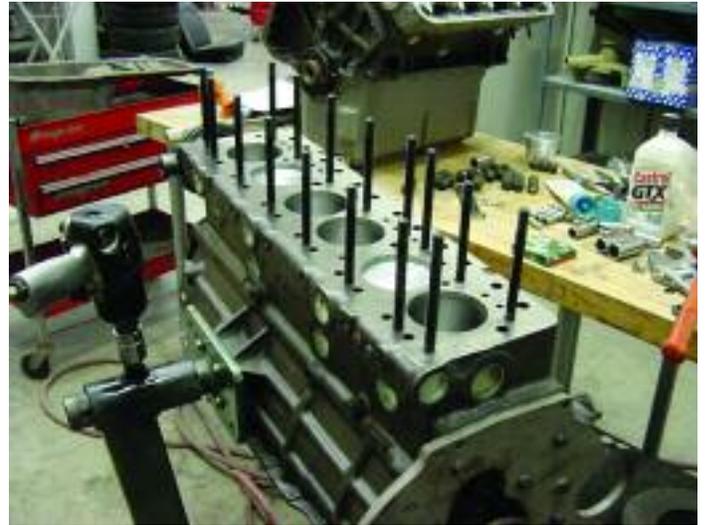
Healey 3000 engine reassembly.

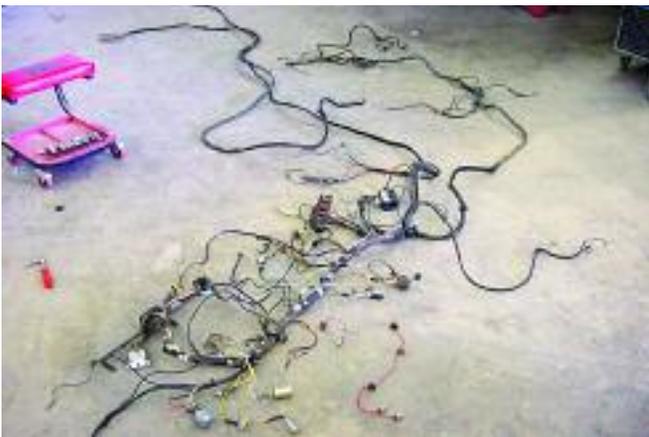
What a mess! Original wiring harness from Maserati 3500.

Secondly, all of the wiring and electrical components are inspected and checked for any problems that may exist with them. The wiring harnesses are then duplicated and components are rebuilt or replaced.

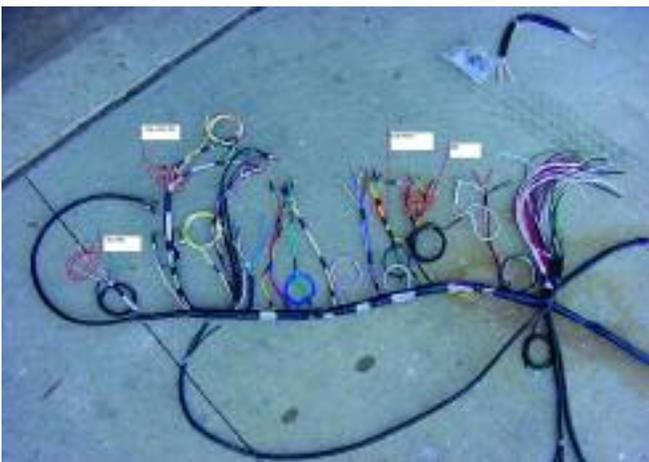
The recreated Maserati 3500 wiring harness.

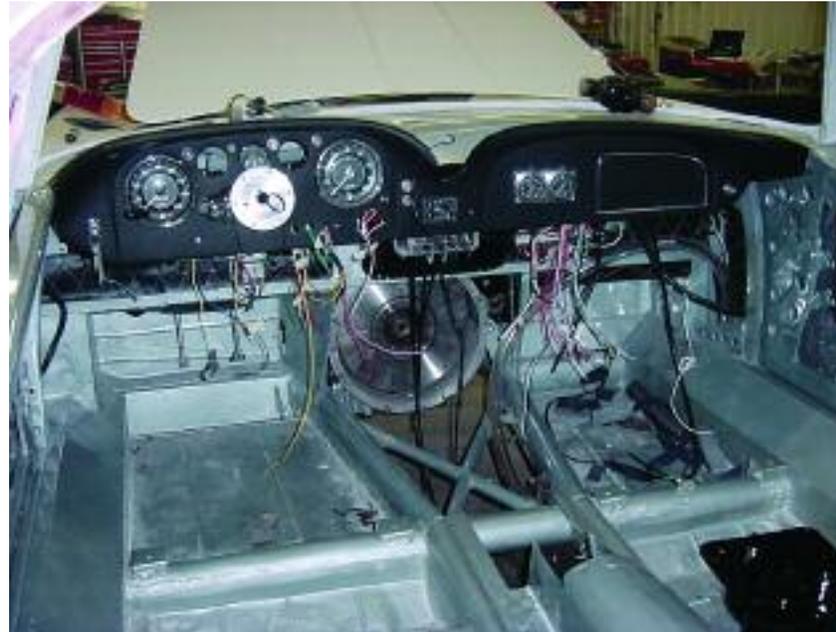
Maserati 3500 dash being assembled.

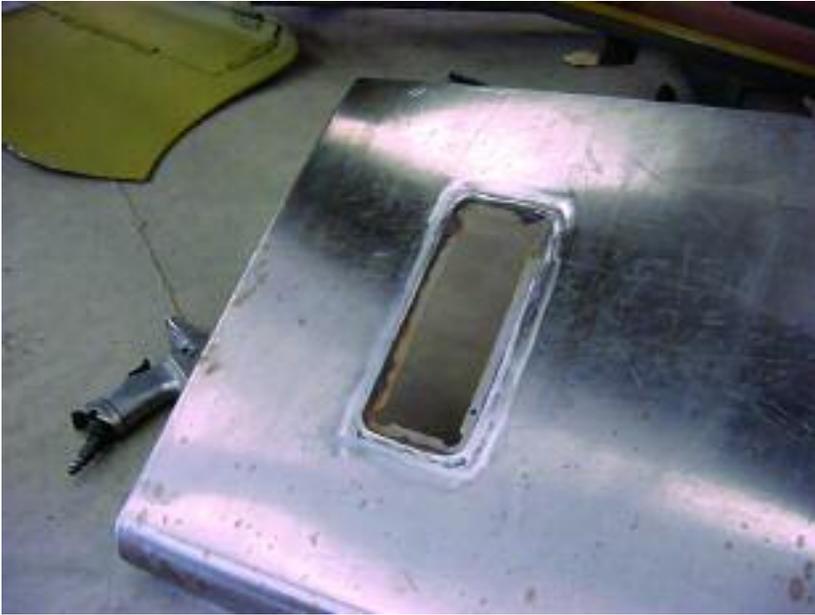
Jaguar XK 140 fender being remade.

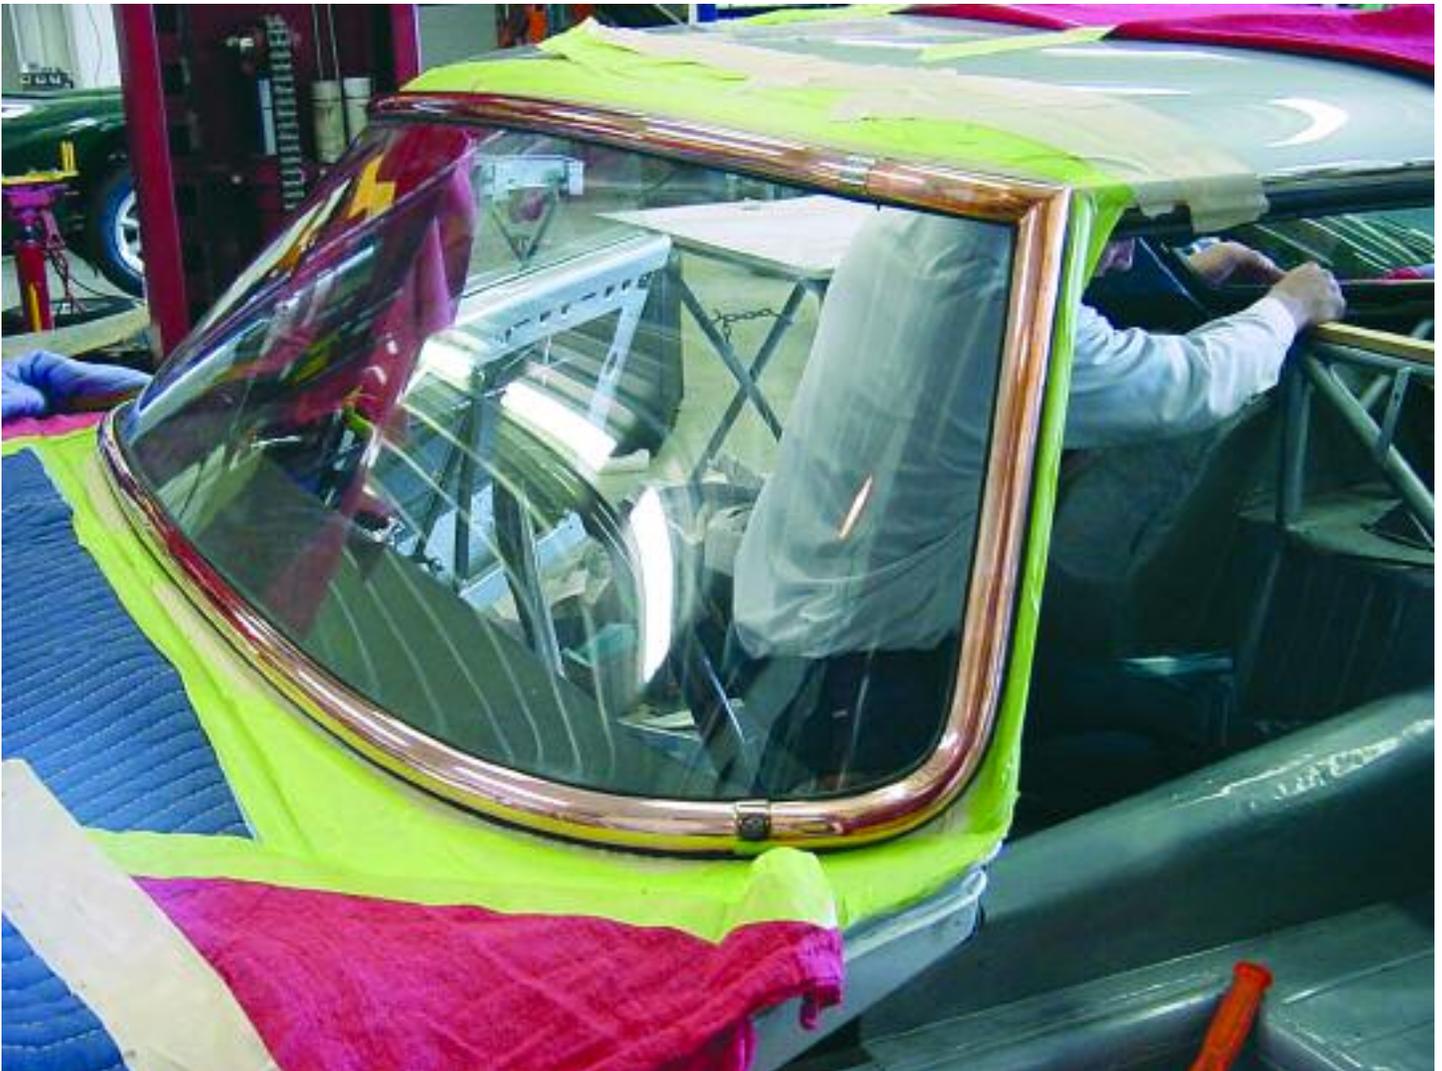
Below: Maserati 3500 windshield prefit of trim, in copper prior to chroming. This is done to ensure proper fit prior to sending the trim for chroming.

At this point, all of the chrome and stainless brightwork is checked and repaired. Then all of the pieces are put away until the body work is completed. The brightwork is then prefit to the car before it goes to chrome. This ensures a perfect fit when the plating comes back for final assembly.

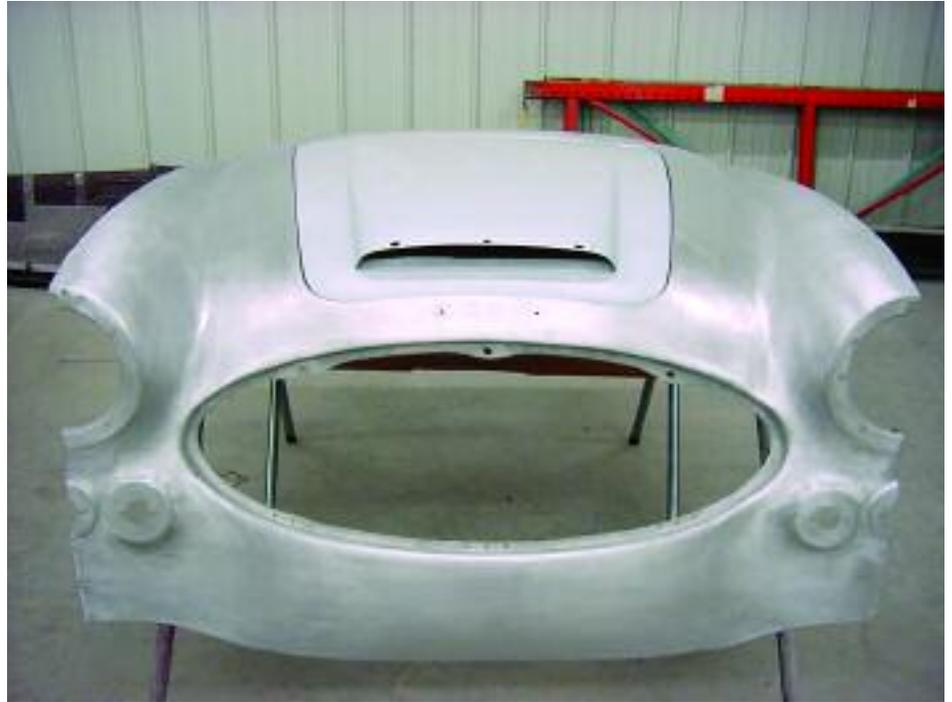
Healey 3000 front hood being fitted to front clip. This ensures proper fit in the final assembly stage.

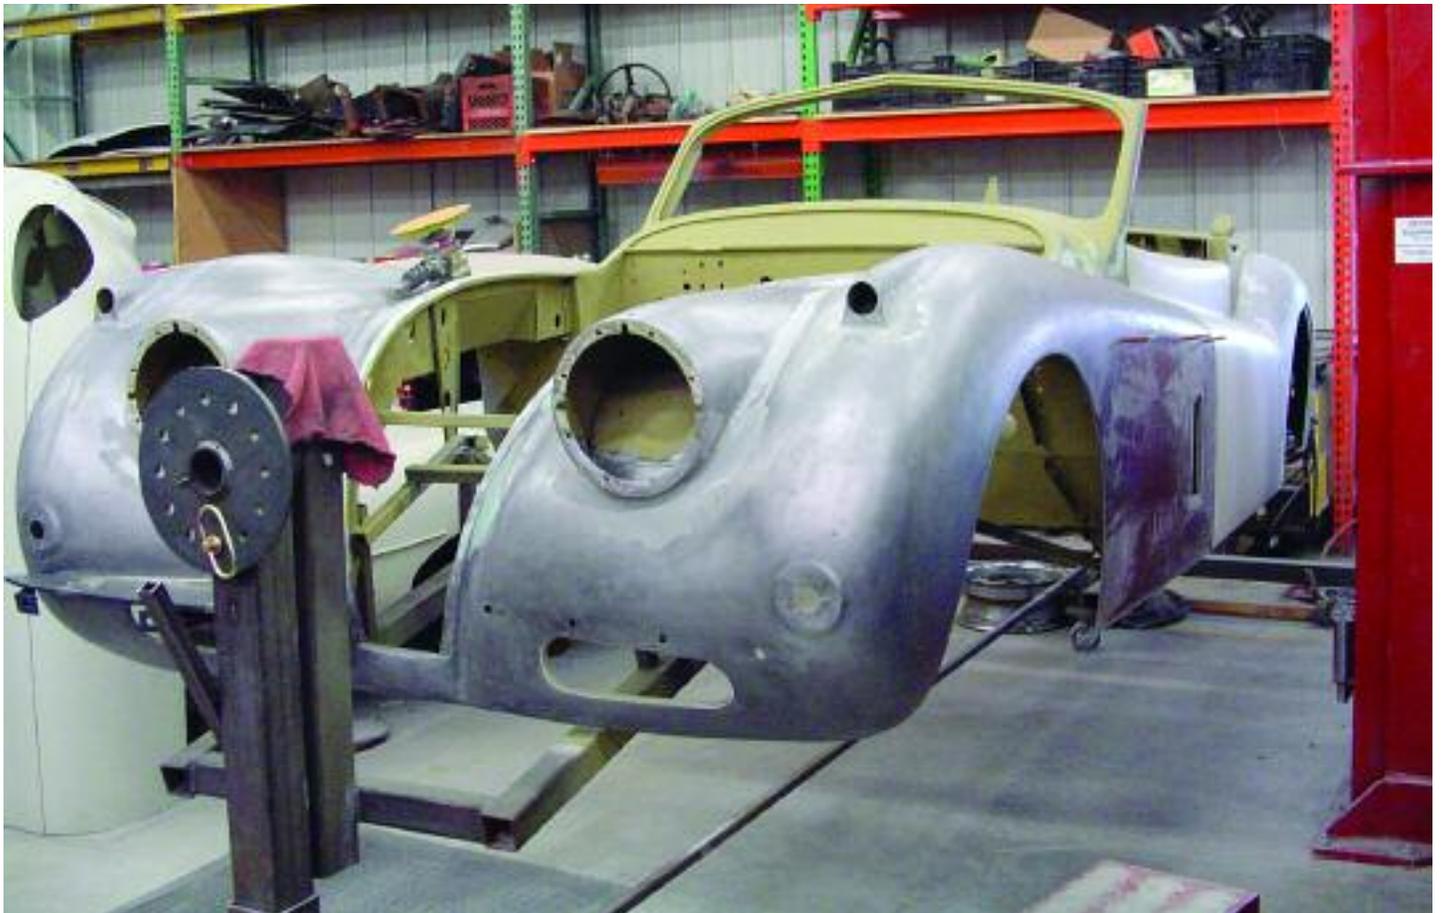
Jaguar XK140 body fit and metal finishing.

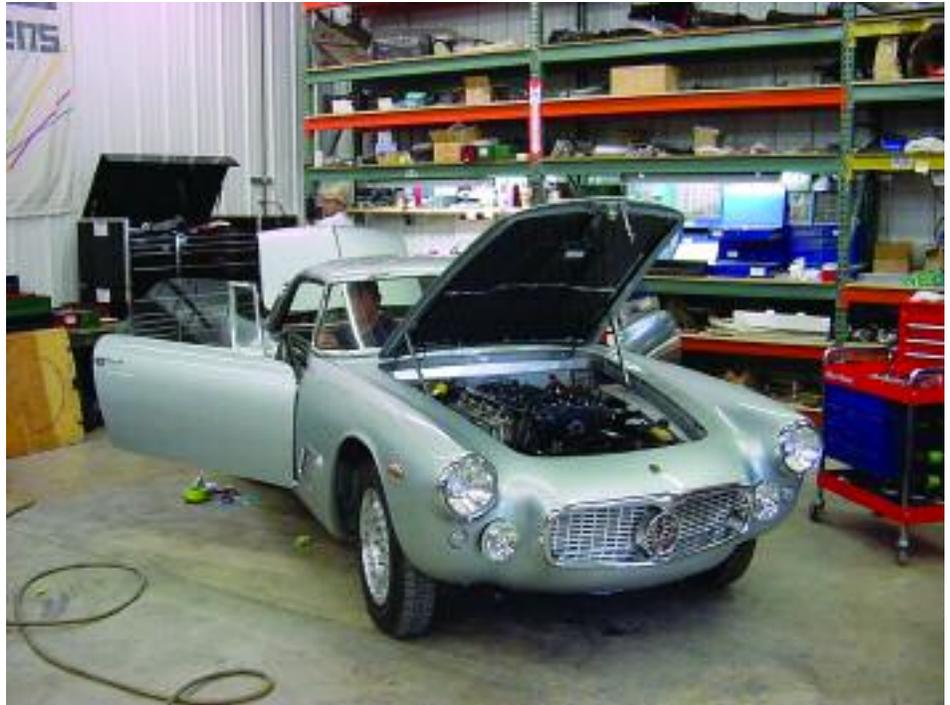
Maserati 3500 in final trim out.
